Access Compliance Report

Public Rights-of-Way

(Curb Ramps)

Intersection ID: 11847	Main Street: N_TRYON_ST	Cross Street: W_9TH_ST	Location: W
ADA ID: B3A4BE052C57	Ramp Type: PerpDiag	Initial Pass/Fail: Fail	Overall Compliance: No
Severity Score: 12.5			
Codes/Mitigation Info/Possible Solution		Field Measurements/Component Compliance

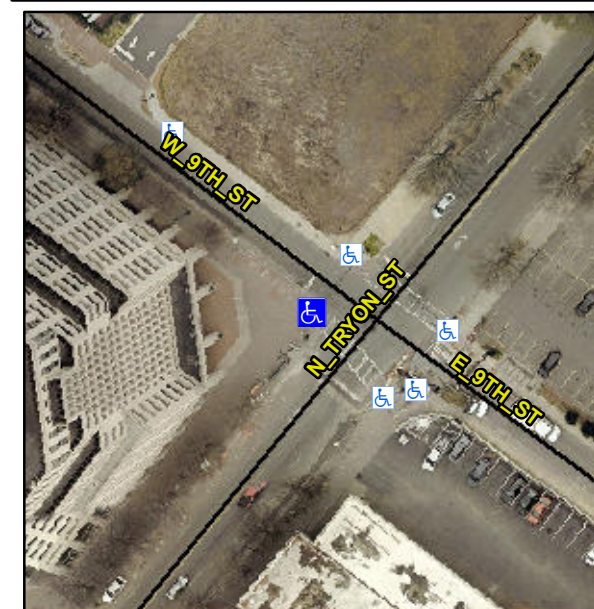
Compliance	Description	Data	Compliance	Description	Data
N/A	Ramp Length (in)	96.0	No	Ramp Slope (%)	10.0
Yes	Ramp Width (in)	48.0	Yes	Ramp XSlope (%)	0.2
N/A	Flare Type LT	N/A	N/A	Flare Type RT	N/A
N/A	Flare Slope LT (%)	N/A	N/A	Flare Slope RT (%)	N/A
N/A	Flare Traversable LT?	N/A	N/A	Flare Traversable RT?	N/A
N/A	Landing Length (in)	N/A	N/A	DWS Provided?	N/A
N/A	Landing Width (in)	N/A	N/A	DWS Contrast?	N/A
N/A	Landing Slope (%)	N/A	N/A	DWS Length (in)	N/A
N/A	Landing X Slope (%)	N/A	N/A	DWS Full Width?	N/A
N/A	Landing Curb? (Y/N)	N/A	N/A	DWS Offset (in)	N/A
N/A	Shared Landing?	N/A			
N/A	Gutter Ponding?	N/A	N/A	Gutter Slope (%)	N/A
N/A	Gutter Lip Ht (in)	N/A	N/A	Gutter X Slope (%)	N/A
N/A	Painted X Walk1?	Yes	N/A	Painted X Walk2?	Yes
	X Walk 1 Direction	To SE		X Walk 2 Direction	To NE
N/A	X Walk 1 Width (in)	103.0	N/A	X Walk 2 Width (in)	106.0
	X Walk 1 Slope (%)	6.2		X Walk 2 Slope (%)	8.1
	X Walk 1 X Slope (%)	3.4		X Walk 2 X Slope (%)	0.4

N/A	Ramp inside XWalk1?	Yes	N/A	Ramp inside XWalk2?	Yes
	Road Slope (%)	3.1	N/A	Clear Space?	N/A
	Road X Slope (%)	6.3	N/A	Clear Space to XWalk (in)	N/A
N/A	Any Obstructions?	N/A	N/A	Storm Grate/Utility Hazard?	N/A
	Obstruction Type			Storm Grate/Utility Type	
		N/A			N/A
		Yes		Surface Condition? (G/P)	Good

Remove & Replace Curb Ramp With Two New Directional Ramps or Equivalent.

R304.2.2
