Access Compliance Report

Public Rights-of-Way

(Curb Ramps)

Intersection ID: 30128	Main Street: GALESBURG_ST	Cross Street: WADENA_DR	Location: SE
ADA ID: B3ACDDBF6C16	Ramp Type: BlendTrans2	Initial Pass/Fail: Fail	Overall Compliance: No
		Severity Score: 1.25

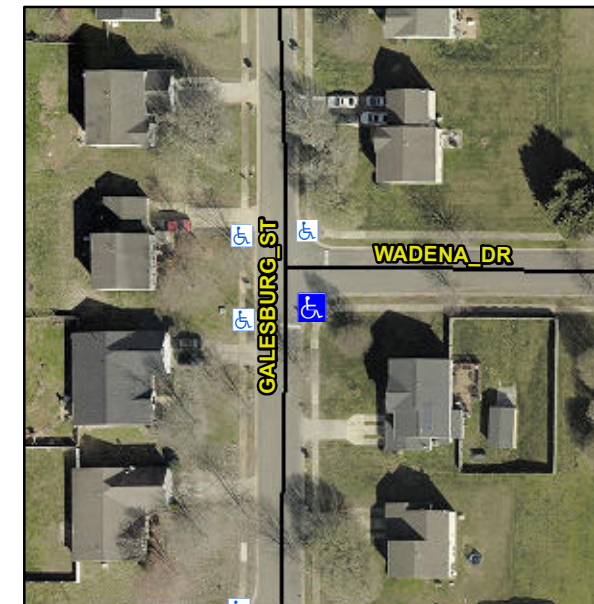
Not Found, R304.5.3

Compliance	Description	Data	Compliance	Description	Data
N/A	Ramp Length (in)	48.0	Yes	BlendTrans Slope (%)	4.7
Yes	Ramp Width (in)	48.0	No	BlendTrans XSlope (%)	2.1
N/A	Flare Type LT	N/A	N/A	Flare Type RT	N/A
N/A	Flare Slope LT (%)	N/A	N/A	Flare Slope RT (%)	N/A
N/A	Flare Traversable LT?	N/A	N/A	Flare Traversable RT?	N/A
N/A	Landing Length (in)	N/A	N/A	DWS Provided?	N/A
N/A	Landing Width (in)	N/A	N/A	DWS Contrast?	N/A
N/A	Landing Slope (%)	N/A	N/A	DWS Length (in)	N/A
N/A	Landing X Slope (%)	N/A	N/A	DWS Full Width?	N/A
N/A	Landing Curb? (Y/N)	N/A	N/A	DWS Offset (in)	N/A
N/A	Shared Landing?	N/A			
N/A	Gutter Ponding?	N/A	N/A	Gutter Slope (%)	N/A
N/A	Gutter Lip Ht (in)	N/A	N/A	Gutter X Slope (%)	N/A
N/A	Painted X Walk1?	No	N/A	Painted X Walk2?	No
	X Walk 1 Direction	To E		X Walk 2 Direction	To N
	X Walk 1 Width (in)	N/A		X Walk 2 Width (in)	N/A
	X Walk 1 Slope (%)	0.4		X Walk 2 Slope (%)	4.1
	X Walk 1 X Slope (%)	1.2		X Walk 2 X Slope (%)	0.1

N/A	Ramp inside XWalk1?	N/A	N/A	Ramp inside XWalk2?	N/A
	Road Slope (%)	2.4		Clear Space?	N/A
	Road X Slope (%)	1.8	N/A	Clear Space to XWalk (in)	N/A
N/A	Any Obstructions?	N/A	N/A	Storm Grate/Utility Hazard?	N/A
	Obstruction Type			Storm Grate/Utility Type	
		N/A			N/A
			Yes	Surface Condition? (G/P)	Good
			No	Curb Slope (%)	16.8

Remove & Replace Curb Ramp With Two New Directional Ramps or Equivalent.
