# Access Compliance Report

## Public Rights-of-Way

### (Curb Ramps)

Intersection ID: 13137	Main Street: CENTRAL_AV	Cross Street: THOMAS_AV	Location: SW
ADA ID: B3AD601F61F2	Ramp Type: Perp	Initial Pass/Fail: Fail	Overall Compliance: No
Severity Score: 22.5			
Codes/Mitigation Info/Possible Solution		Field Measurements/Component Compliance

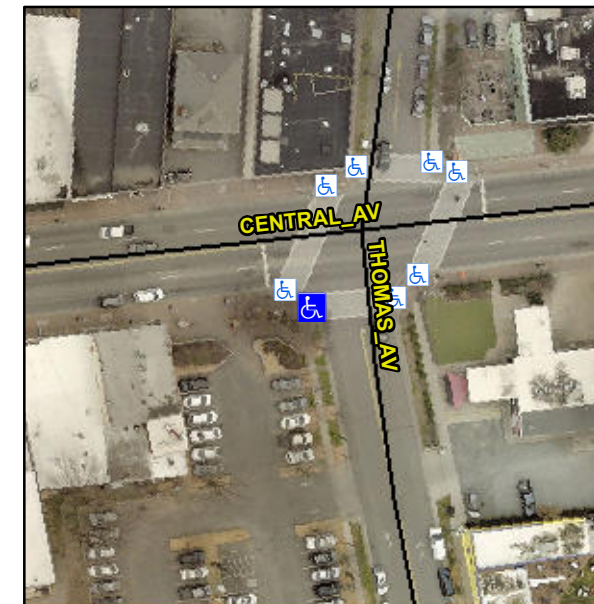
**Not Found, R304.5.1, R304.2.2, R304.5.3**

Compliance	Description	Data	Compliance	Description	Data
N/A	Ramp Length (in)	72.0	No	Ramp Slope (%)	9.5
No	Ramp Width (in)	46.0	No	Ramp XSlope (%)	2.3
N/A	Flare Type LT	N/A	N/A	Flare Type RT	N/A
N/A	Flare Slope LT (%)	N/A	N/A	Flare Slope RT (%)	N/A
N/A	Flare Traversable LT?	N/A	N/A	Flare Traversable RT?	N/A
N/A	Landing Length (in)	N/A	N/A	DWS Provided?	N/A
N/A	Landing Width (in)	N/A	N/A	DWS Contrast?	N/A
N/A	Landing Slope (%)	N/A	N/A	DWS Length (in)	N/A
N/A	Landing X Slope (%)	N/A	N/A	DWS Full Width?	N/A
N/A	Landing Curb? (Y/N)	N/A	N/A	DWS Offset (in)	N/A
N/A	Shared Landing?	N/A			
N/A	Gutter Ponding?	N/A	N/A	Gutter Slope (%)	N/A
N/A	Gutter Lip Ht (in)	N/A	N/A	Gutter X Slope (%)	N/A
N/A	Painted X Walk1?	Yes	N/A	Painted X Walk2?	N/A
	X Walk 1 Direction	To E		X Walk 2 Direction	N/A
N/A	X Walk 1 Width (in)	140.0	N/A	X Walk 2 Width (in)	N/A
	X Walk 1 Slope (%)	4.5		X Walk 2 Slope (%)	N/A
	X Walk 1 X Slope (%)	0.2		X Walk 2 X Slope (%)	N/A

N/A	Ramp inside XWalk1?	Yes	N/A	Ramp inside XWalk2?	N/A
	Road Slope (%)	N/A	N/A	Clear Space?	N/A
	Road X Slope (%)	N/A	N/A	Clear Space to XWalk (in)	N/A
N/A	Any Obstructions?	N/A	N/A	Storm Grate/Utility Hazard?	N/A
	Obstruction Type			Storm Grate/Utility Type	
		N/A			N/A
			Yes	Surface Condition? (G/P)	Good

**Remove & Replace Entire Ramp.**
