Access Compliance Report

Public Rights-of-Way

(Curb Ramps)

Intersection ID: 48134	Main Street: SQUIRREL_TRAIL_LN	Cross Street: ACORN_CREEK_LN	Location: NW
ADA ID: B3B32CAB3CA9	Ramp Type: PerpDiag	Initial Pass/Fail: Fail	Overall Compliance: No
Severity Score: 17.5			
Codes/Mitigation Info/Possible Solution		Field Measurements/Component Compliance

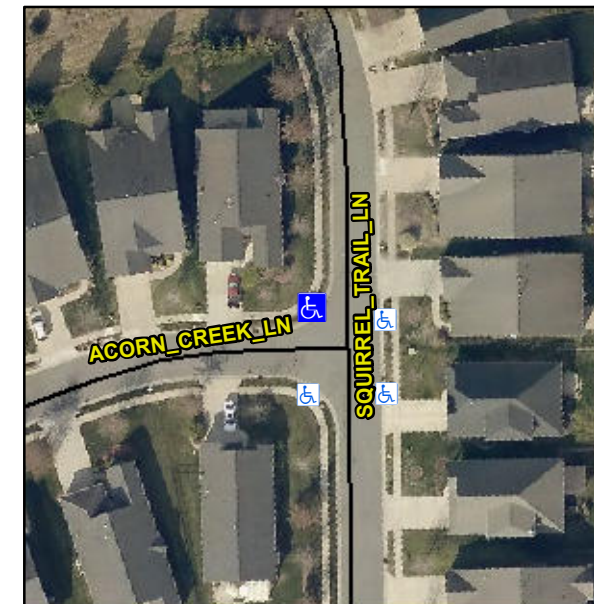
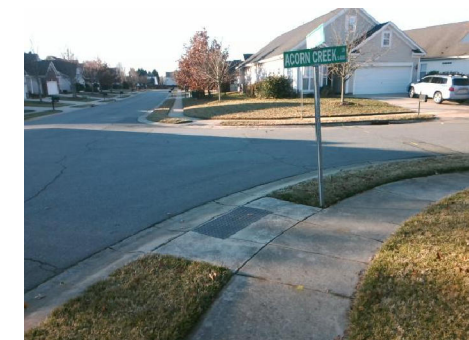
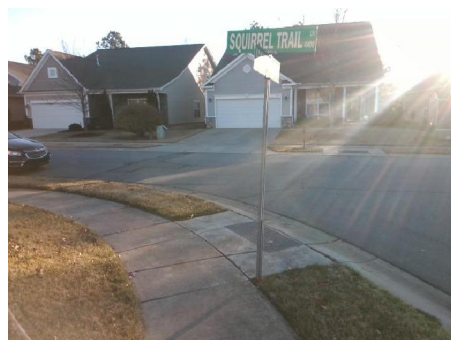
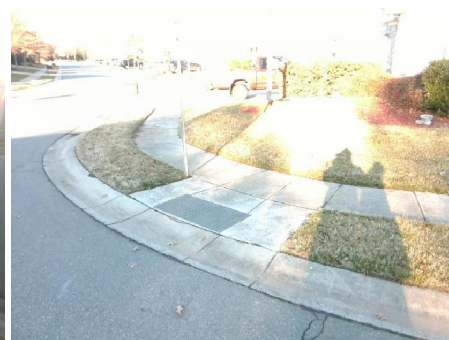
Not Found, R304.5.1

Compliance	Description	Data	Compliance	Description	Data
N/A	Ramp Length (in)	46.0	Yes	Ramp Slope (%)	5.1
No	Ramp Width (in)	35.0	Yes	Ramp XSlope (%)	1.2
N/A	Flare Type LT	N/A	N/A	Flare Type RT	N/A
N/A	Flare Slope LT (%)	N/A	N/A	Flare Slope RT (%)	N/A
N/A	Flare Traversable LT?	N/A	N/A	Flare Traversable RT?	N/A
N/A	Landing Length (in)	N/A	N/A	DWS Provided?	N/A
N/A	Landing Width (in)	N/A	N/A	DWS Contrast?	N/A
N/A	Landing Slope (%)	N/A	N/A	DWS Length (in)	N/A
N/A	Landing X Slope (%)	N/A	N/A	DWS Full Width?	N/A
N/A	Landing Curb? (Y/N)	N/A	N/A	DWS Offset (in)	N/A
N/A	Shared Landing?	N/A			
N/A	Gutter Ponding?	N/A	N/A	Gutter Slope (%)	N/A
N/A	Gutter Lip Ht (in)	N/A	N/A	Gutter X Slope (%)	N/A
N/A	Painted X Walk1?	No	N/A	Painted X Walk2?	No
	X Walk 1 Direction	To S		X Walk 2 Direction	To E
N/A	X Walk 1 Width (in)	N/A	N/A	X Walk 2 Width (in)	N/A
	X Walk 1 Slope (%)	0.2		X Walk 2 Slope (%)	1.6
	X Walk 1 X Slope (%)	1.1		X Walk 2 X Slope (%)	1.6

N/A	Ramp inside XWalk1?	N/A	N/A	Ramp inside XWalk2?	N/A
	Road Slope (%)	1.2	N/A	Clear Space?	N/A
	Road X Slope (%)	1.4	N/A	Clear Space to XWalk (in)	N/A
N/A	Any Obstructions?	N/A	N/A	Storm Grate/Utility Hazard?	N/A
	Obstruction Type			Storm Grate/Utility Type	
		N/A			N/A
		Yes		Surface Condition? (G/P)	Good

Remove & Replace Curb Ramp With Two New Directional Ramps or Equivalent.
