# Access Compliance Report

## Public Rights-of-Way

| Intersection ID: 19622 | Main Street: SARDIS_RD | Cross Street: SARDIS_VIEW_RD | Location: SW |
| ADA ID: B3BA988364C5 | Ramp Type: PerpDiag | Initial Pass/Fail: Fail | Overall Compliance: No |

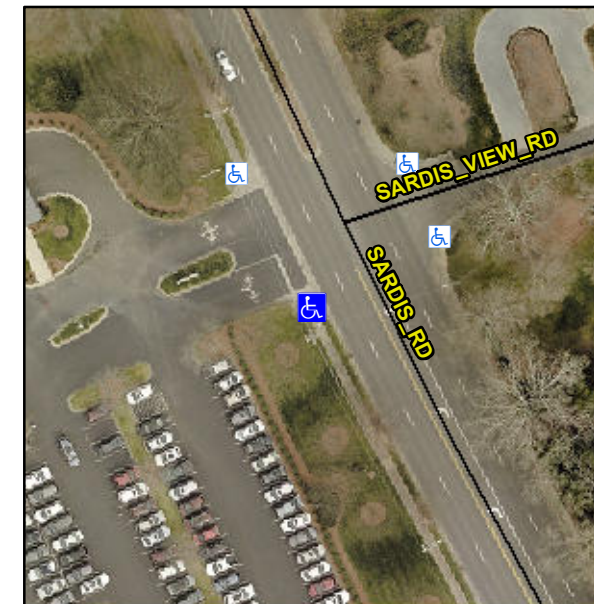
| | | Severity Score: 10 | |

**Not Found, R304.5.1, R304.5.3**

| Compliance | Description | Data | Compliance | Description | Data |
|---|---|---|---|---|---|
| N/A | Ramp Length (in) | 58.0 | Yes | Ramp Slope (%) | 6.3 |
| No | Ramp Width (in) | 39.0 | No | Ramp XSlope (%) | 4.7 |

**Remove & Replace Curb Ramp With Two New Directional Ramps or Equivalent.**

Total Cost: \$ 3200.00
