Access Compliance Report

Public Rights-of-Way

(Curb Ramps)

Intersection ID: 7793	Main Street: JEFF_ADAMS_DR	Cross Street: STATESVILLE_AV	Location: NE
ADA ID: B3BBAE63A55F	Ramp Type: Perp	Initial Pass/Fail: Fail	Overall Compliance: No
Severity Score: 13.75			
Codes/Mitigation Info/Possible Solution		Field Measurements/Component Compliance

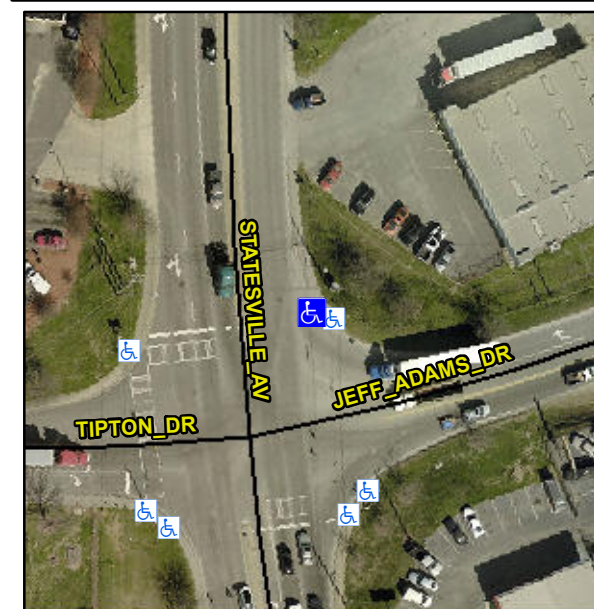
Not Found, R304.2.2, R304.5.3

Compliance	Description	Data	Compliance	Description	Data
N/A	Ramp Length (in)	60.0	No	Ramp Slope (%)	11.2
Yes	Ramp Width (in)	48.0	No	Ramp XSlope (%)	2.2
N/A	Flare Type LT	N/A	N/A	Flare Type RT	N/A
N/A	Flare Slope LT (%)	N/A	N/A	Flare Slope RT (%)	N/A
N/A	Flare Traversable LT?	N/A	N/A	Flare Traversable RT?	N/A
N/A	Landing Length (in)	N/A	N/A	DWS Provided?	N/A
N/A	Landing Width (in)	N/A	N/A	DWS Contrast?	N/A
N/A	Landing Slope (%)	N/A	N/A	DWS Length (in)	N/A
N/A	Landing X Slope (%)	N/A	N/A	DWS Full Width?	N/A
N/A	Landing Curb? (Y/N)	N/A	N/A	DWS Offset (in)	N/A
N/A	Shared Landing?	N/A			
N/A	Gutter Ponding?	N/A	N/A	Gutter Slope (%)	N/A
N/A	Gutter Lip Ht (in)	N/A	N/A	Gutter X Slope (%)	N/A
N/A	Painted X Walk1?	No	N/A	Painted X Walk2?	N/A
	X Walk 1 Direction	To W		X Walk 2 Direction	N/A
N/A	X Walk 1 Width (in)	N/A	N/A	X Walk 2 Width (in)	N/A
	X Walk 1 Slope (%)	1.5		X Walk 2 Slope (%)	N/A
	X Walk 1 X Slope (%)	0.9		X Walk 2 X Slope (%)	N/A

Remove & Replace Entire Ramp.
