Access Compliance Report

Public Rights-of-Way

(Curb Ramps)

Intersection ID: 32074	Main Street: SPRINGBANK_LN	Cross Street: SPRINGS_VILLAGE_LN	Location: NE
ADA ID: B3BFA071C70F	Ramp Type: PerpDiag	Initial Pass/Fail: Fail	Overall Compliance: No
Severity Score: 13.75			
Codes/Mitigation Info/Possible Solution		Field Measurements/Component Compliance

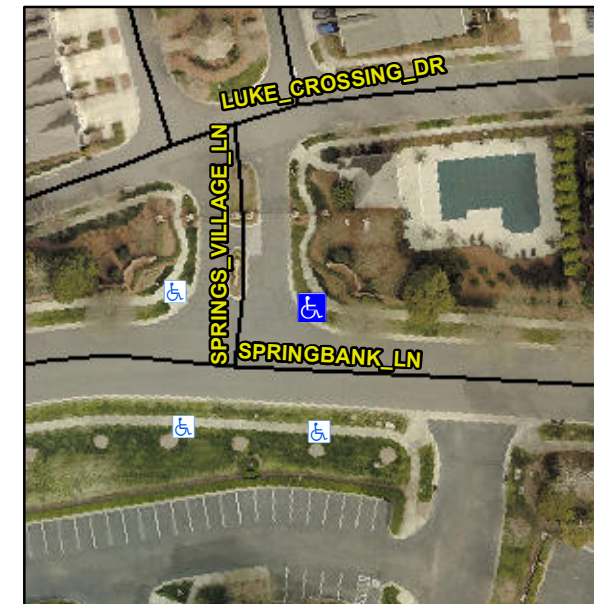
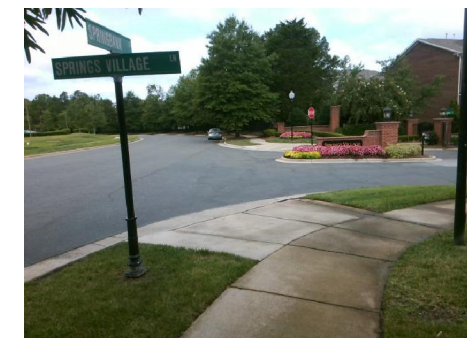
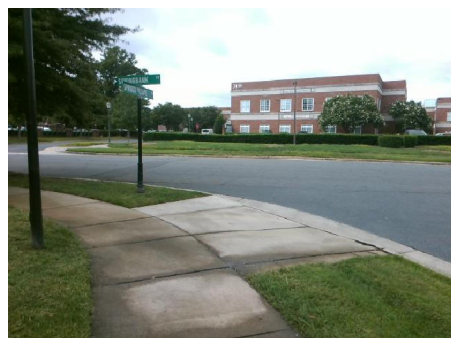
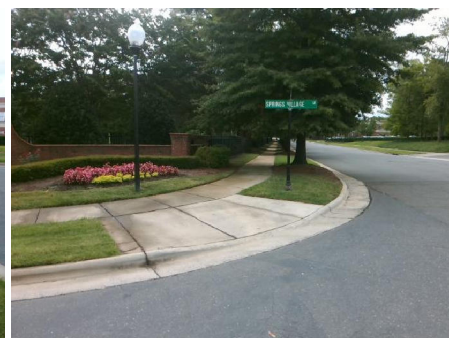
Not Found, R304.2.2, R304.5.3

Compliance	Description	Data	Compliance	Description	Data
N/A	Ramp Length (in)	96.0	No	Ramp Slope (%)	11.1
Yes	Ramp Width (in)	51.0	No	Ramp XSlope (%)	2.7
N/A	Flare Type LT	N/A	N/A	Flare Type RT	N/A
N/A	Flare Slope LT (%)	N/A	N/A	Flare Slope RT (%)	N/A
N/A	Flare Traversable LT?	N/A	N/A	Flare Traversable RT?	N/A
N/A	Landing Length (in)	N/A	N/A	DWS Provided?	N/A
N/A	Landing Width (in)	N/A	N/A	DWS Contrast?	N/A
N/A	Landing Slope (%)	N/A	N/A	DWS Length (in)	N/A
N/A	Landing X Slope (%)	N/A	N/A	DWS Full Width?	N/A
N/A	Landing Curb? (Y/N)	N/A	N/A	DWS Offset (in)	N/A
N/A	Shared Landing?	N/A			
N/A	Gutter Ponding?	N/A	N/A	Gutter Slope (%)	N/A
N/A	Gutter Lip Ht (in)	N/A	N/A	Gutter X Slope (%)	N/A
N/A	Painted X Walk1?	No	N/A	Painted X Walk2?	No
	X Walk 1 Direction	To NW		X Walk 2 Direction	To S
N/A	X Walk 1 Width (in)	N/A	N/A	X Walk 2 Width (in)	N/A
	X Walk 1 Slope (%)	1.0		X Walk 2 Slope (%)	7.2
	X Walk 1 X Slope (%)	5.5		X Walk 2 X Slope (%)	3.4

N/A	Ramp inside XWalk1?	N/A	N/A	Ramp inside XWalk2?	N/A
	Road Slope (%)	2.7	N/A	Clear Space?	N/A
	Road X Slope (%)	6.0	N/A	Clear Space to XWalk (in)	N/A
N/A	Any Obstructions?	N/A	N/A	Storm Grate/Utility Hazard?	N/A
	Obstruction Type			Storm Grate/Utility Type	
		N/A			N/A
		Yes		Surface Condition? (G/P)	Good

Possible Solutions:

Remove & Replace Curb Ramp With Two New Directional Ramps or Equivalent.
