# Access Compliance Report

## Public Rights-of-Way

### (Curb Ramps)

Intersection ID: 51511	Main Street: PEARL_PARK_WY	Cross Street: S_KINGS_DR	Location: NW
ADA ID: B3C348788AFB	Ramp Type: Perp	Initial Pass/Fail: Fail	Overall Compliance: No
Severity Score: 22.5			
Codes/Mitigation Info/Possible Solution		Field Measurements/Component Compliance

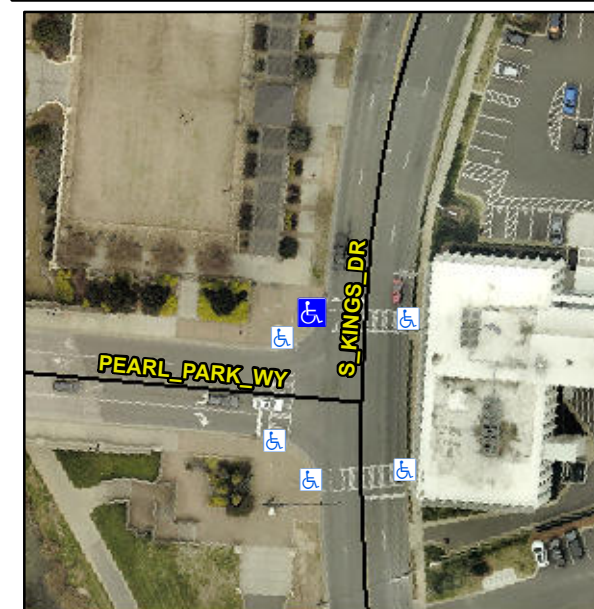
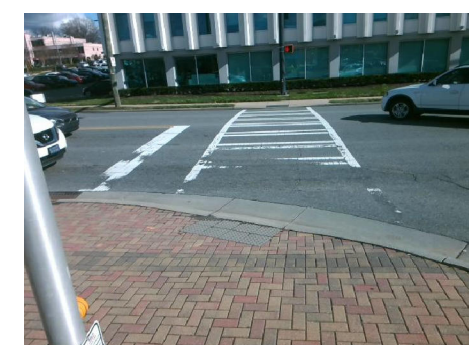
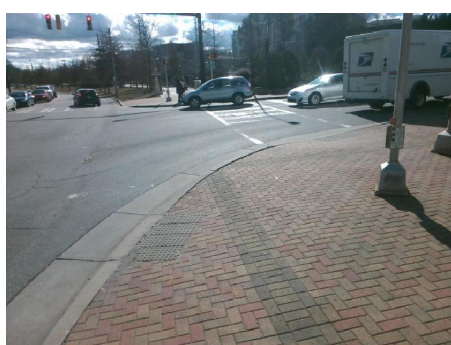
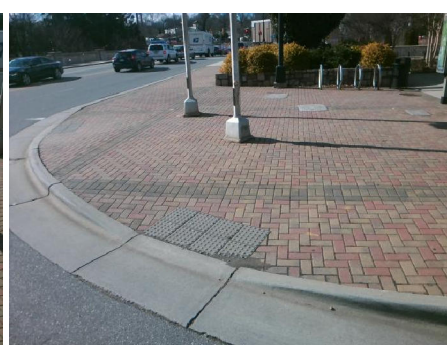
**Not Found, R304.5.1, R304.2.2, R304.5.3**

Compliance	Description	Data	Compliance	Description	Data
N/A	Ramp Length (in)	48.0	No	Ramp Slope (%)	9.7
No	Ramp Width (in)	47.0	No	Ramp XSlope (%)	3.6
N/A	Flare Type LT	N/A	N/A	Flare Type RT	N/A
N/A	Flare Slope LT (%)	N/A	N/A	Flare Slope RT (%)	N/A
N/A	Flare Traversable LT?	N/A	N/A	Flare Traversable RT?	N/A
N/A	Landing Length (in)	N/A	N/A	DWS Provided?	N/A
N/A	Landing Width (in)	N/A	N/A	DWS Contrast?	N/A
N/A	Landing Slope (%)	N/A	N/A	DWS Length (in)	N/A
N/A	Landing X Slope (%)	N/A	N/A	DWS Full Width?	N/A
N/A	Landing Curb? (Y/N)	N/A	N/A	DWS Offset (in)	N/A
N/A	Shared Landing?	N/A			
N/A	Gutter Ponding?	N/A	N/A	Gutter Slope (%)	N/A
N/A	Gutter Lip Ht (in)	N/A	N/A	Gutter X Slope (%)	N/A
N/A	Painted X Walk1?	Yes	N/A	Painted X Walk2?	N/A
	X Walk 1 Direction	To E		X Walk 2 Direction	N/A
N/A	X Walk 1 Width (in)	120.0	N/A	X Walk 2 Width (in)	N/A
	X Walk 1 Slope (%)	2.9		X Walk 2 Slope (%)	N/A
	X Walk 1 X Slope (%)	2.6		X Walk 2 X Slope (%)	N/A

N/A	Ramp inside XWalk1?	Yes	N/A	Ramp inside XWalk2?	N/A
	Road Slope (%)	N/A	N/A	Clear Space?	N/A
	Road X Slope (%)	N/A	N/A	Clear Space to XWalk (in)	N/A
N/A	Any Obstructions?	N/A	N/A	Storm Grate/Utility Hazard?	N/A
	Obstruction Type			Storm Grate/Utility Type	
		N/A			N/A
		Yes		Surface Condition? (G/P)	Good

**Remove & Replace Entire Ramp.**

Total Cost: \$ 1850.00
