Access Compliance Report

Public Rights-of-Way

(Curb Ramps)

Intersection ID: 3189	Main Street: SHELLY_PINES_DR	Cross Street: MALLARD_WOODS_PL	Location: SW
ADA ID: B3C3494C1435	Ramp Type: Perp	Initial Pass/Fail: Fail	Overall Compliance: No
		Severity Score: 37.5

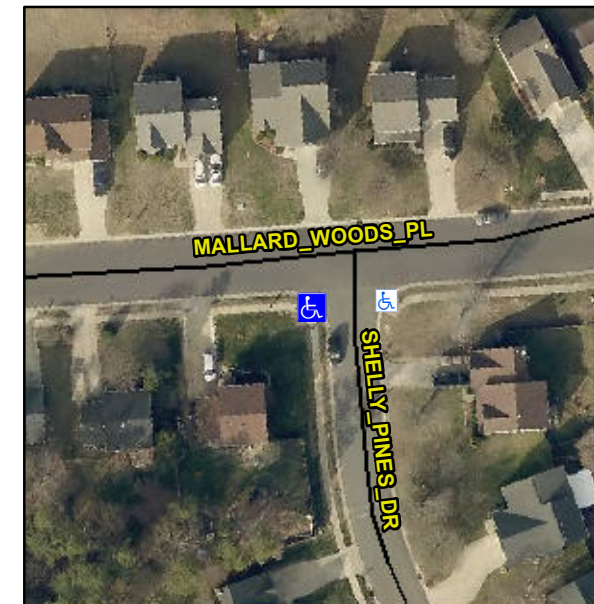
Not Found, R304.2.2, R304.5.3

Compliance	Description	Data	Compliance	Description	Data
N/A	Ramp Length (in)	48.0	No	Ramp Slope (%)	11.6
Yes	Ramp Width (in)	55.0	No	Ramp XSlope (%)	12.3
N/A	Flare Type LT	N/A	N/A	Flare Type RT	N/A
N/A	Flare Slope LT (%)	N/A	N/A	Flare Slope RT (%)	N/A
N/A	Flare Traversable LT?	N/A	N/A	Flare Traversable RT?	N/A
N/A	Landing Length (in)	N/A	N/A	DWS Provided?	N/A
N/A	Landing Width (in)	N/A	N/A	DWS Contrast?	N/A
N/A	Landing Slope (%)	N/A	N/A	DWS Length (in)	N/A
N/A	Landing X Slope (%)	N/A	N/A	DWS Full Width?	N/A
N/A	Landing Curb? (Y/N)	N/A	N/A	DWS Offset (in)	N/A
N/A	Shared Landing?	N/A			
N/A	Gutter Ponding?	N/A	N/A	Gutter Slope (%)	N/A
N/A	Gutter Lip Ht (in)	N/A	N/A	Gutter X Slope (%)	N/A
N/A	Painted X Walk1?	No	N/A	Painted X Walk2?	N/A
	X Walk 1 Direction	To E		X Walk 2 Direction	N/A
N/A	X Walk 1 Width (in)	N/A	N/A	X Walk 2 Width (in)	N/A
	X Walk 1 Slope (%)	4.8		X Walk 2 Slope (%)	N/A
	X Walk 1 X Slope (%)	8.0		X Walk 2 X Slope (%)	N/A

N/A	Ramp inside XWalk1?	N/A	N/A	Ramp inside XWalk2?	N/A
	Road Slope (%)	N/A	N/A	Clear Space?	N/A
	Road X Slope (%)	N/A	N/A	Clear Space to XWalk (in)	N/A
N/A	Any Obstructions?	N/A	N/A	Storm Grate/Utility Hazard?	N/A
	Obstruction Type			Storm Grate/Utility Type	
		N/A			N/A
			Yes	Surface Condition? (G/P)	Good

Remove & Replace Entire Ramp.

Total Cost: \$ 1850.00
