Access Compliance Report

Public Rights-of-Way

(Curb Ramps)

Intersection ID: N/A	Main Street: BEAM_RD	Cross Street: YORKMONT_RD	Location: W
ADA ID: B3C549C1B55B	Ramp Type: Perp	Initial Pass/Fail: Fail	Overall Compliance: No
			Severity Score: 46.25

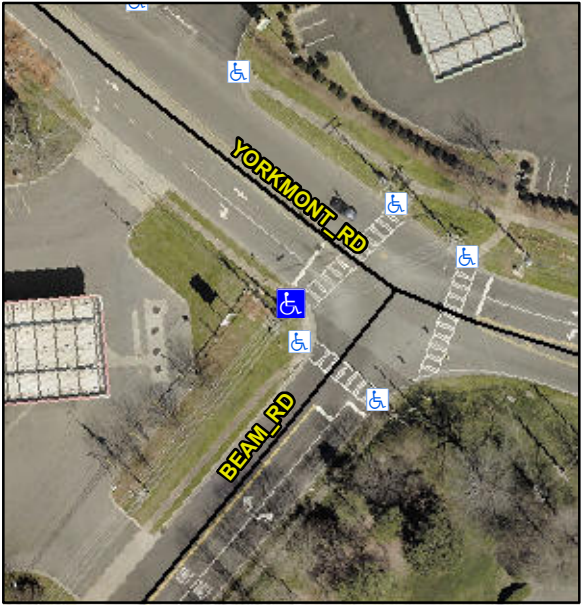
Possible Solutions:		Compliance	Description	Data
	Remove & Replace Entire Ramp.		No	Ramp Length (in)	51.0
			No	Ramp Width (in)	41.0
			N/A	Flare Type LT	N/A
			N/A	Flare Slope LT (%)	N/A
			N/A	Flare Traversable LT?	N/A
			N/A	Landing Length (in)	N/A
			N/A	Landing Width (in)	N/A
			N/A	Landing Slope (%)	N/A
			N/A	Landing X Slope (%)	N/A
<p>Surveyor Notes:</p> <p>N/A</p> <p>PROW/ADA:</p> <p>Not Found, R304.5.1, R304.2.2, R304.5.3</p>			N/A	Flare Type RT	N/A
			N/A	Flare Slope RT (%)	N/A
			N/A	Flare Traversable RT?	N/A
			N/A	DWS Provided?	N/A
			N/A	DWS Contrast?	N/A
			N/A	DWS Length (in)	N/A
			N/A	DWS Full Width?	N/A
			N/A	DWS Offset (in)	N/A
			N/A	Shared Landing?	N/A
			N/A	Gutter Ponding?	N/A
			N/A	Gutter Lip Ht (in)	N/A
			N/A	Painted X Walk1?	Yes
				X Walk 1 Direction	To NE
			N/A	X Walk 1 Width (in)	112.0
				X Walk 1 Slope (%)	6.5

X Walk 1 X Slope (%)	1.7
			N/A	Ramp inside XWalk1?	Yes
			N/A	Road Slope (%)	N/A
			N/A	Road X Slope (%)	N/A
			N/A	Any Obstructions?	N/A
Total Cost:		\$ 1850.00		Obstruction Type	
			N/A		N/A
			Yes	Surface Condition? (G/P)	Good
