Access Compliance Report

Public Rights-of-Way

Intersection ID: 46789	Main Street: STOWE_ACRES_DR	Cross Street: WILTON_GATE_DR	Location: SE
ADA ID: B3D621ECB5A2	Ramp Type: PerpDiag	Initial Pass/Fail: Fail	Overall Compliance: No
Severity Score: 22.5			
Codes/Mitigation Info/Possible Solution		Field Measurements/Component Compliance

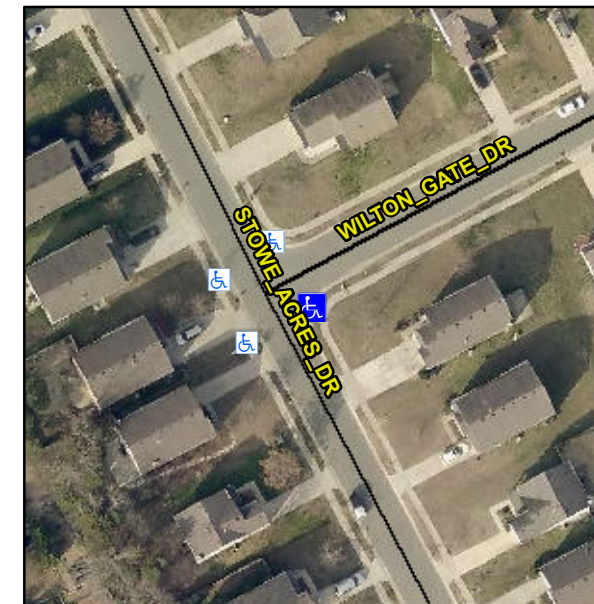
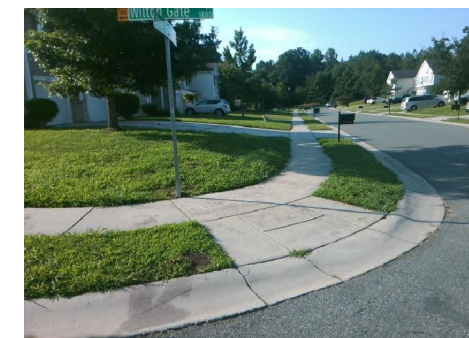
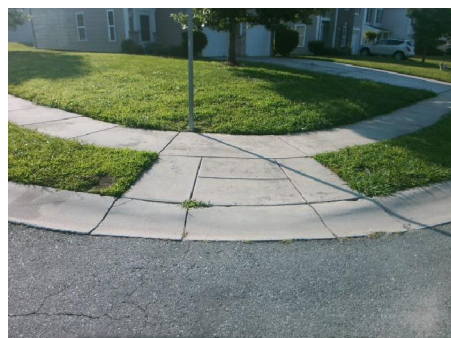
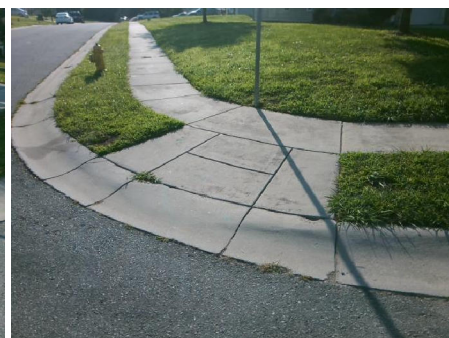
Not Found, R304.5.1, R304.2.2, R304.5.3

Compliance	Description	Data	Compliance	Description	Data
N/A	Ramp Length (in)	48.5	No	Ramp Slope (%)	9.3
No	Ramp Width (in)	37.5	No	Ramp XSlope (%)	2.8
N/A	Flare Type LT	N/A	N/A	Flare Type RT	N/A
N/A	Flare Slope LT (%)	N/A	N/A	Flare Slope RT (%)	N/A
N/A	Flare Traversable LT?	N/A	N/A	Flare Traversable RT?	N/A
N/A	Landing Length (in)	N/A	N/A	DWS Provided?	N/A
N/A	Landing Width (in)	N/A	N/A	DWS Contrast?	N/A
N/A	Landing Slope (%)	N/A	N/A	DWS Length (in)	N/A
N/A	Landing X Slope (%)	N/A	N/A	DWS Full Width?	N/A
N/A	Landing Curb? (Y/N)	N/A	N/A	DWS Offset (in)	N/A
N/A	Shared Landing?	N/A			
N/A	Gutter Ponding?	N/A	N/A	Gutter Slope (%)	N/A
N/A	Gutter Lip Ht (in)	N/A	N/A	Gutter X Slope (%)	N/A
N/A	Painted X Walk1?	No	N/A	Painted X Walk2?	No
	X Walk 1 Direction	To N		X Walk 2 Direction	To W
N/A	X Walk 1 Width (in)	N/A	N/A	X Walk 2 Width (in)	N/A
	X Walk 1 Slope (%)	1.1		X Walk 2 Slope (%)	0.0
	X Walk 1 X Slope (%)	0.6		X Walk 2 X Slope (%)	0.0

N/A	Ramp inside XWalk1?	N/A	N/A	Ramp inside XWalk2?	N/A
	Road Slope (%)	1.6	N/A	Clear Space?	N/A
	Road X Slope (%)	0.1	N/A	Clear Space to XWalk (in)	N/A
N/A	Any Obstructions?	N/A	N/A	Storm Grate/Utility Hazard?	N/A
	Obstruction Type			Storm Grate/Utility Type	
		N/A			N/A
			Yes	Surface Condition? (G/P)	Good

Remove & Replace Curb Ramp With Two New Directional Ramps or Equivalent.
