# Access Compliance Report

## Public Rights-of-Way

### (Curb Ramps)

Intersection ID: 17886	Main Street: PROVIDENCE_RD	Cross Street: VERNON_DR	Location: NE
ADA ID: B3DF3E84B8DD	Ramp Type: PerpDiag	Initial Pass/Fail: Fail	Overall Compliance: No
		Severity Score: 35

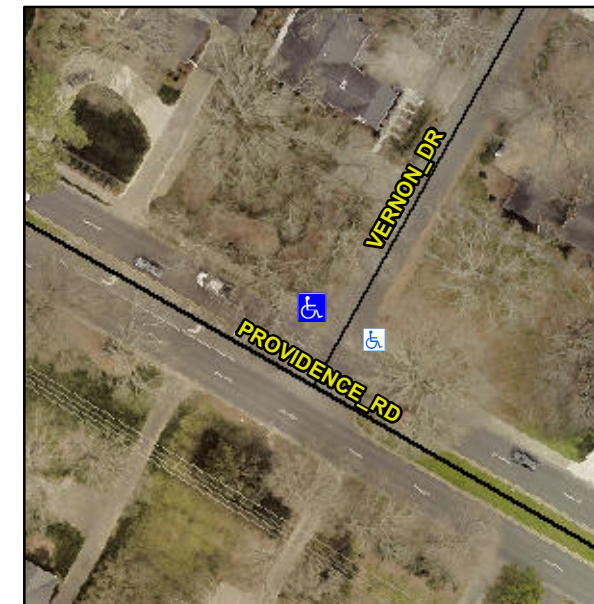
**Not Found, R304.5.1**

Compliance	Description	Data	Compliance	Description	Data
N/A	Ramp Length (in)	57.0	Yes	Ramp Slope (%)	6.6
No	Ramp Width (in)	30.5	Yes	Ramp XSlope (%)	0.0
N/A	Flare Type LT	N/A	N/A	Flare Type RT	N/A
N/A	Flare Slope LT (%)	N/A	N/A	Flare Slope RT (%)	N/A
N/A	Flare Traversable LT?	N/A	N/A	Flare Traversable RT?	N/A
N/A	Landing Length (in)	N/A	N/A	DWS Provided?	N/A
N/A	Landing Width (in)	N/A	N/A	DWS Contrast?	N/A
N/A	Landing Slope (%)	N/A	N/A	DWS Length (in)	N/A
N/A	Landing X Slope (%)	N/A	N/A	DWS Full Width?	N/A
N/A	Landing Curb? (Y/N)	N/A	N/A	DWS Offset (in)	N/A
N/A	Shared Landing?	N/A			
N/A	Gutter Ponding?	N/A	N/A	Gutter Slope (%)	N/A
N/A	Gutter Lip Ht (in)	N/A	N/A	Gutter X Slope (%)	N/A
N/A	Painted X Walk1?	No	N/A	Painted X Walk2?	No
	X Walk 1 Direction	To SW		X Walk 2 Direction	To SE
N/A	X Walk 1 Width (in)	N/A	N/A	X Walk 2 Width (in)	N/A
	X Walk 1 Slope (%)	5.3		X Walk 2 Slope (%)	1.4
	X Walk 1 X Slope (%)	5.7		X Walk 2 X Slope (%)	6.3

N/A	Ramp inside XWalk1?	N/A	N/A	Ramp inside XWalk2?	N/A
	Road Slope (%)	0.5	N/A	Clear Space?	N/A
	Road X Slope (%)	1.1	N/A	Clear Space to XWalk (in)	N/A
N/A	Any Obstructions?	N/A	N/A	Storm Grate/Utility Hazard?	N/A
	Obstruction Type			Storm Grate/Utility Type	
		N/A			N/A
			Yes	Surface Condition? (G/P)	Good

**Remove & Replace Curb Ramp With Two New Directional Ramps or Equivalent.**

Total Cost: \$ 3200.00
