Access Compliance Report Public Rights-of-Way (Curb Ramps)

Intersection ID: 10025524 Main Street: E PARK AV **Cross Street: N/A** Location: Ε

ADA ID: B3E29A20447A Ramp Type: PerpDiag Initial Pass/Fail: Pass **Overall Compliance: No Severity Score:** 35

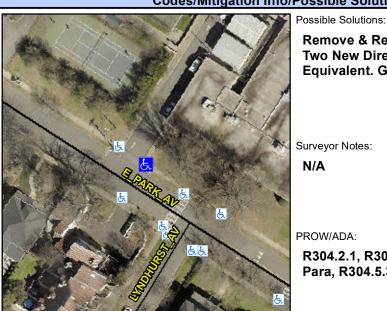
ENTRANCE Street 1 Name Stop Condition-Street 2 None Street 2 Name **E PARK AV** Stop Condition-Street 1 None

Compliance Description		Data	Comp	liance Desc	ription	Data
N/A	Ramp Length (in)	60.0	Yes	Ramp Slope (%)		5.5
Yes	Ramp Width (in)	48.0	Yes	Ramp XSlope (%)		0.5
N/A	Flare Type LT	Sloped	N/A	Flare Type RT		N/A
N/A	Flare Slope LT (%)	3.5	Yes	Flare Slope RT (%)		2.8
N/A	Flare Traversable LT?	Yes	N/A	Flare Traversable RT?		Yes
No	Landing Length (in)	N/A	No	DWS Provided?		No
No	Landing Width (in)	N/A	N/A	DWS Contrast?		No
No	Landing Slope (%)	N/A	N/A	DWS Length (in)		N/A
No	Landing X Slope (%)	N/A	N/A	DWS Full Width?		No
N/A	Landing Curb? (Y/N)	No	N/A	DWS Offset (in)		N/A
N/A	Shared Landing?	N/A				
Yes	Gutter Ponding?	No	Yes	Gutter Slope (%)		4.5
No	Gutter Lip Ht (in)	2.0	Yes	Gutter X Slope (%)		1.6
N/A	Painted X Walk1?	No	N/A	Painted X Walk2?		No
	X Walk 1 Direction	To NW		X Walk 2 Direction		To SW
N/A	X Walk 1 Width (in)	N/A	N/A	X Walk 2 Width (in)		N/A
	X Walk 1 Slope (%)	6.3		X Walk 2 Slope (%)		2.1
	X Walk 1 X Slope (%)	2.6		X Walk 2 X Slope (%)		5.5

N/A	Ramp inside XWalk1?	N/A	N/A	Ramp inside	e XWalk2?	N/A
	Road Slope (%)	3.9	N/A	Clear Space	e?	Yes
	Road X Slope (%)	6.1	N/A	Clear Space	e to XWalk (in)	N/A
Yes	Any Obstructions?	No	Yes	Storm Grate	e/Utility Hazard?	No
	Obstruction Type		l	Storm Grate/Utility Type		
		N/A			N/A	
			Yes	Surface Co	ndition? (G/P)	Good

Remove & Replace Curb Ramp With Two New Directional Ramps or **Equivalent. Grind Gutter Lip.**

R304.2.1, R304.2.2-Perp, R304.3.2-Para, R304.5.3, R305, R302.7.2
