# Access Compliance Report

## Public Rights-of-Way

### (Curb Ramps)

| Intersection ID: 19016 | Main Street: BARCLAY_DOWNS_DR | Cross Street: SAGAMORE_RD | Location: SW |

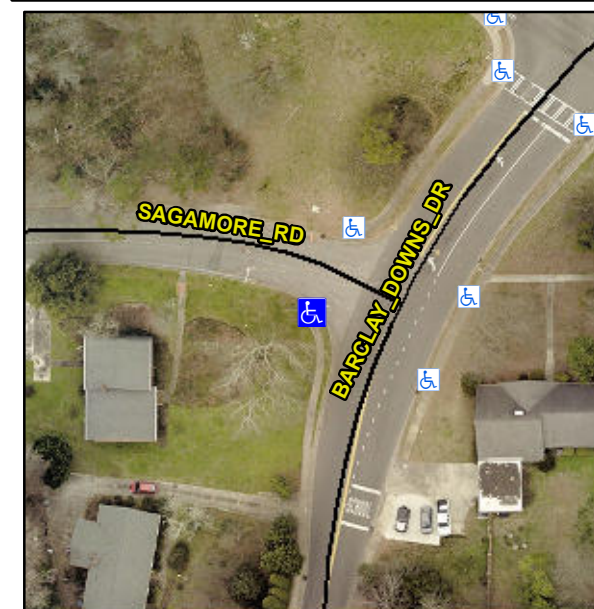
| ADA ID: B3EB11CC89B5 | Ramp Type: BlendTrans1 | Initial Pass/Fail: Fail | Overall Compliance: No |
| Severity Score: 10 | | | |

**Not Found, R304.5.1, R304.5.3**

| Compliance | Description | Data | Compliance | Description | Data |
|---|---|---|---|---|---|
| No | Ramp Width (in) | 44.0 | No | BlendTrans XSlope (%) | 2.2 |
| | | | No | Curb Slope (%) | 19.9 |

**Remove & Replace Curb Ramp With Two New Directional Ramps or Equivalent.**

Total Cost: \$ 3200.00
