# Access Compliance Report

## Public Rights-of-Way

### (Curb Ramps)

Intersection ID: N/A	Main Street: FIVE_KNOLLS_DR	Cross Street: MACDARA_GLENN_CT	Location: NW
ADA ID: B3F16AC6D96B	Ramp Type: BlendTrans2	Initial Pass/Fail: Fail	Overall Compliance: No
		Severity Score: 8.75

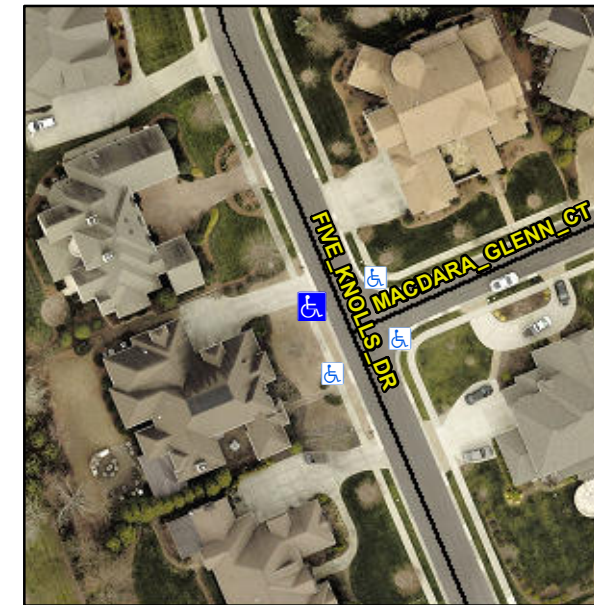
**CURB LIP 2.0**

**Not Found, R304.5.1**

Compliance	Description	Data	Compliance	Description	Data
N/A	Ramp Length (in)	96.0	Yes	BlendTrans Slope (%)	4.2
No	Ramp Width (in)	46.0	Yes	BlendTrans XSlope (%)	0.1
N/A	Flare Type LT	N/A	N/A	Flare Type RT	N/A
N/A	Flare Slope LT (%)	N/A	N/A	Flare Slope RT (%)	N/A
N/A	Flare Traversable LT?	N/A	N/A	Flare Traversable RT?	N/A
N/A	Landing Length (in)	N/A	N/A	DWS Provided?	N/A
N/A	Landing Width (in)	N/A	N/A	DWS Contrast?	N/A
N/A	Landing Slope (%)	N/A	N/A	DWS Length (in)	N/A
N/A	Landing X Slope (%)	N/A	N/A	DWS Full Width?	N/A
N/A	Landing Curb? (Y/N)	N/A	N/A	DWS Offset (in)	N/A
N/A	Shared Landing?	N/A			
N/A	Gutter Ponding?	N/A	N/A	Gutter Slope (%)	N/A
N/A	Gutter Lip Ht (in)	N/A	N/A	Gutter X Slope (%)	N/A
N/A	Painted X Walk1?	No	N/A	Painted X Walk2?	N/A
	X Walk 1 Direction	To NE		X Walk 2 Direction	N/A
	X Walk 1 Width (in)	N/A		X Walk 2 Width (in)	N/A
	X Walk 1 Slope (%)	1.5		X Walk 2 Slope (%)	N/A
	X Walk 1 X Slope (%)	1.4		X Walk 2 X Slope (%)	N/A

N/A	Ramp inside XWalk1?	N/A	N/A	Ramp inside XWalk2?	N/A
	Road Slope (%)	1.4		Clear Space?	N/A
	Road X Slope (%)	1.5	N/A	Clear Space to XWalk (in)	N/A
N/A	Any Obstructions?	N/A	N/A	Storm Grate/Utility Hazard?	N/A
	Obstruction Type			Storm Grate/Utility Type	
		N/A			N/A
			Yes	Surface Condition? (G/P)	Good
			No	Curb Slope (%)	13.3

**Remove & Replace Curb Ramp With Two New Directional Ramps or Equivalent.**
