# Access Compliance Report

## Public Rights-of-Way

### (Curb Ramps)

| Intersection ID: 14648 | | Main Street: EAST_BV | | Cross Street: LENNOX_AV | | Location: NE | | | |

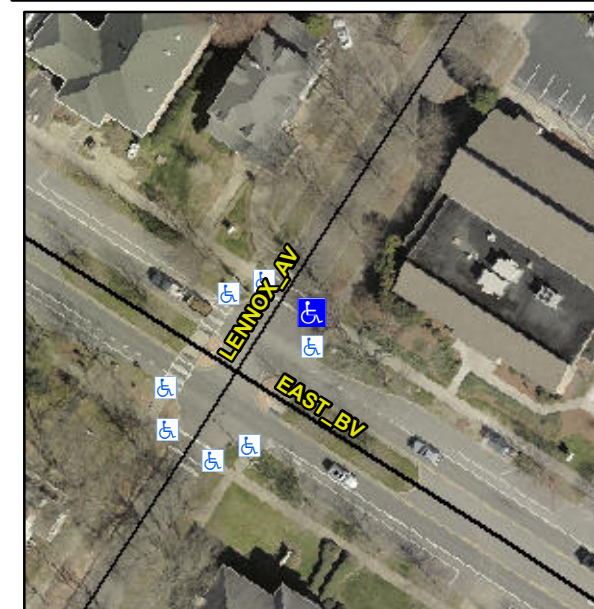
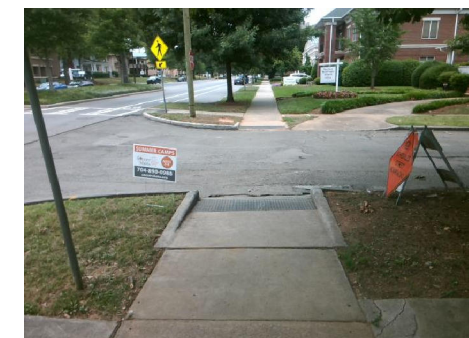
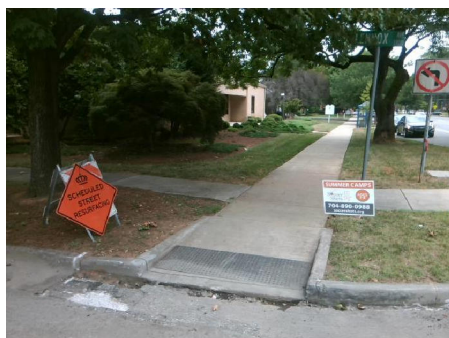
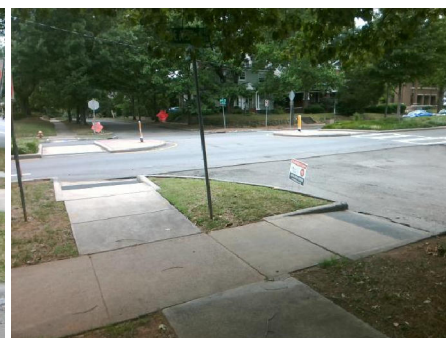
| ADA ID: B3F1DA88A0FB | | Ramp Type: Perp | | Initial Pass/Fail: Pass | | Overall Compliance: No | | Severity Score: 15 | |

**Not Found, R304.2.1, R305.2, R302.7.2**

| Compliance | Description | Data | Compliance | Description | Data |
|---|---|---|---|---|---|
| No | Landing Length (in) | 45.0 | Yes | DWS Provided? | Yes |
| N/A | Landing Curb? (Y/N) | No | No | DWS Offset (in) | 3.0 |
| No | Gutter Lip Ht (in) | 4.0 | Yes | Gutter X Slope (%) | 0.6 |

**Remove & Replace Entire Ramp.**
