| Intersection ID: 47902 | Main Street: SPUR_RANCH_RD | Cross Street: ROUND_ROCK_RD | Location: | NE |
| ADA ID: B3F86C51FD65 | Ramp Type: PerpDiag | Initial Pass/Fail: Fail | Overall Compliance: No | Severity Score: 8.75 |

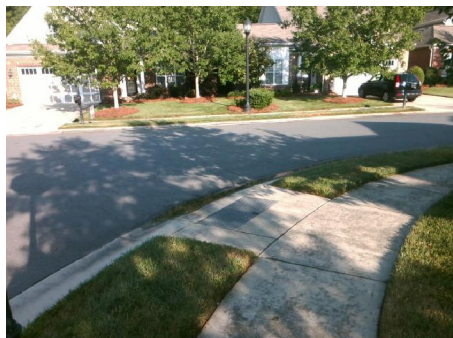
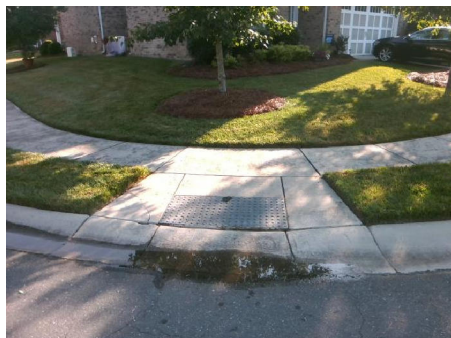
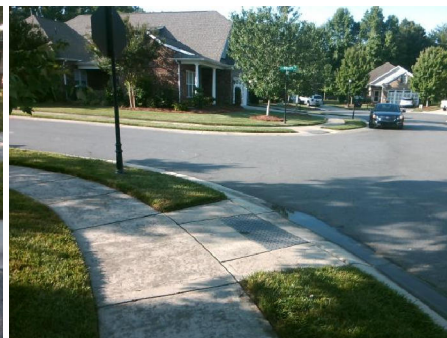
| Codes/Mitigation Info/Possible Solution | | | Field Measurements/Component Compliance | | | | | |
|---|---|--|---|---|---|---|---|---|
| | | | No | Ramp Width (in) | 46.5 | Yes | Ramp XSlope (%) | 0.9 |
| PROW/ADA: | | | N/A | Gutter Ponding? | Yes | N/A | Gutter Slope (%) | N/A |
| | Not Found, R304.5.1 | | N/A | Gutter Lip Ht (in) | 0.5 | N/A | Gutter X Slope (%) | N/A |

| Codes/Mitigation Info/Possible Solution | | | Field Measurements/Component Compliance | | | | | |
|---|---|--|---|---|---|---|---|---|
| | Remove & Replace Curb Ramp With Two New Directional Ramps or Equivalent. | | N/A | Ramp Length (in) | 47.0 | Yes | Ramp Slope (%) | 5.0 |
| Total Cost: | \$ 3200.00 | | | | N/A | | | N/A |
