# Access Compliance Report

## Public Rights-of-Way

### (Curb Ramps)

Intersection ID: 15287	Main Street: ALBEMARLE_RD	Cross Street: N_SHARON_AMITY_RD	Location: NW
ADA ID: B407CBAC2714	Ramp Type: Perp	Initial Pass/Fail: Fail	Overall Compliance: No
Severity Score: 8.75			
Codes/Mitigation Info/Possible Solution		Field Measurements/Component Compliance

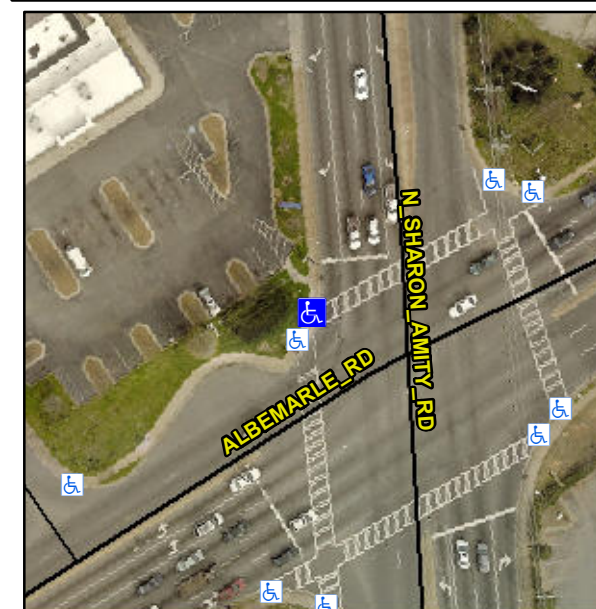
Compliance	Description	Data	Compliance	Description	Data
N/A	Ramp Length (in)	60.0	Yes	Ramp Slope (%)	7.1
No	Ramp Width (in)	47.5	Yes	Ramp XSlope (%)	0.7
N/A	Flare Type LT	N/A	N/A	Flare Type RT	N/A
N/A	Flare Slope LT (%)	N/A	N/A	Flare Slope RT (%)	N/A
N/A	Flare Traversable LT?	N/A	N/A	Flare Traversable RT?	N/A
N/A	Landing Length (in)	N/A	N/A	DWS Provided?	N/A
N/A	Landing Width (in)	N/A	N/A	DWS Contrast?	N/A
N/A	Landing Slope (%)	N/A	N/A	DWS Length (in)	N/A
N/A	Landing X Slope (%)	N/A	N/A	DWS Full Width?	N/A
N/A	Landing Curb? (Y/N)	N/A	N/A	DWS Offset (in)	N/A
N/A	Shared Landing?	N/A			
N/A	Gutter Ponding?	N/A	N/A	Gutter Slope (%)	N/A
N/A	Gutter Lip Ht (in)	N/A	N/A	Gutter X Slope (%)	N/A
N/A	Painted X Walk1?	Yes	N/A	Painted X Walk2?	N/A
	X Walk 1 Direction	To NE		X Walk 2 Direction	N/A
N/A	X Walk 1 Width (in)	106.0	N/A	X Walk 2 Width (in)	N/A
	X Walk 1 Slope (%)	2.3		X Walk 2 Slope (%)	N/A
	X Walk 1 X Slope (%)	2.6		X Walk 2 X Slope (%)	N/A

N/A	Ramp inside XWalk1?	Yes	N/A	Ramp inside XWalk2?	N/A
	Road Slope (%)	N/A	N/A	Clear Space?	N/A
	Road X Slope (%)	N/A	N/A	Clear Space to XWalk (in)	N/A
N/A	Any Obstructions?	N/A	N/A	Storm Grate/Utility Hazard?	N/A
	Obstruction Type			Storm Grate/Utility Type	
		N/A			N/A
			Yes	Surface Condition? (G/P)	Good

**Remove & Replace Entire Ramp.**

**Not Found, R304.5.1**
