Access Compliance Report

Public Rights-of-Way

(Curb Ramps)

Intersection ID: 17670	Main Street: RIDGEWOOD_AV	Cross Street: SELWYN_AV	Location: NW
ADA ID: B409D2B98E5D	Ramp Type: Directional1	Initial Pass/Fail: Fail	Overall Compliance: No
		Severity Score: 1.25

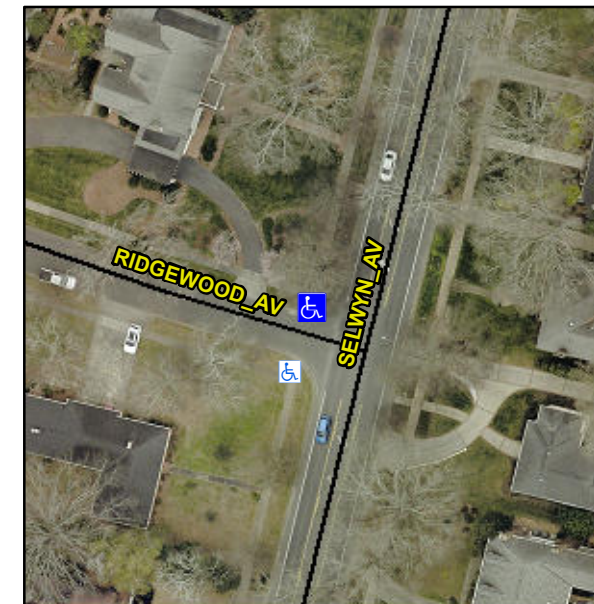
R304.5.3

Compliance	Description	Data	Compliance	Description	Data
N/A	Ramp Length (in)	63.0	N/A	Grade Break?	N/A
Yes	Ramp Width (in)	59.0	N/A	Grade Break Slope (%)	0.0
Yes	Ramp Slope (%)	6.7	N/A	Grade Break XSlope (%)	0.0
No	Ramp XSlope (%)	3.3			
N/A	Flare Type LT	N/A	N/A	Flare Type RT	N/A
N/A	Flare Slope LT (%)	N/A	N/A	Flare Slope RT (%)	0.0
N/A	Flare Traversable LT?	N/A	N/A	Flare Traversable RT?	N/A
N/A	Landing Length (in)	0.0	N/A	DWS Provided?	N/A
N/A	Landing Width (in)	0.0	N/A	DWS Contrast?	N/A
N/A	Landing Slope (%)	0.0	N/A	DWS Length (in)	N/A
N/A	Landing X Slope (%)	0.0	N/A	DWS Full Width?	N/A
N/A	Landing Curb? (Y/N)	N/A	N/A	DWS Offset LT (in)	N/A
N/A	Shared Landing?	N/A	N/A	DWS Offset RT (in)	N/A
N/A	Gutter Ponding?	0.0	N/A	Gutter Slope (%)	N/A
N/A	Gutter Lip Ht (in)	0.0	N/A	Gutter X Slope (%)	N/A
N/A	Painted X Walk1?	No		Road Slope (%)	5.3
	X Walk 1 Direction	To SW		Road X Slope (%)	0.3
	X Walk 1 Width (in)	N/A		Clear Space?	N/A

X Walk 1 Slope (%)	5.3	N/A	Clear Space to XWalk (in)	N/A
	X Walk 1 X Slope (%)	0.3	N/A	Storm Grate/Utility Hazard?	N/A
N/A	Ramp inside XWalk1?	N/A		Storm Grate/Utility Type	
N/A	Any Obstructions?	N/A			N/A
	Obstruction Type		Yes	Surface Condition? (G/P)	Good
			N/A	Curb Slope (%)	3.7

Remove & Replace Entire Ramp.
