Access Compliance Report

Public Rights-of-Way

(Curb Ramps)

Intersection ID: 18301	Main Street: MCLAUGHLIN_DR	Cross Street: OLD_POST_RD	Location: NW
ADA ID: B411F79B1526	Ramp Type: Directional1	Initial Pass/Fail: Pass	Overall Compliance: No
		Severity Score: 0

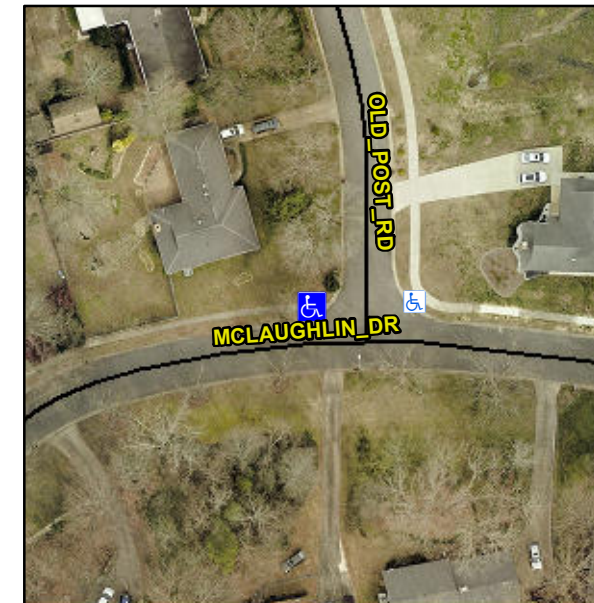
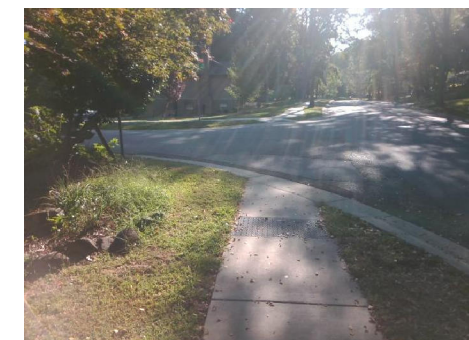
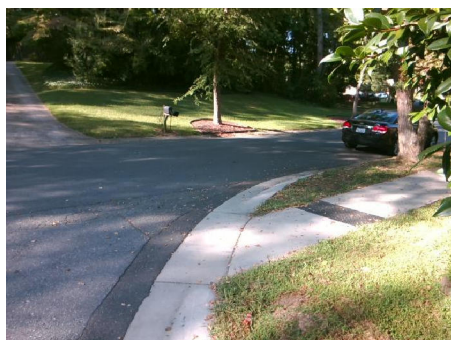
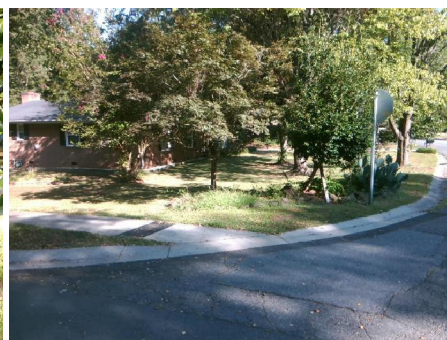
Compliance	Description	Data	Compliance	Description	Data
N/A	Ramp Length (in)	72.0	Yes	Grade Break?	Yes
Yes	Ramp Width (in)	48.0	Yes	Grade Break Slope (%)	2.5
Yes	Ramp Slope (%)	3.8	Yes	Grade Break XSlope (%)	1.3
Yes	Ramp XSlope (%)	1.0			
N/A	Flare Type LT	N/A	N/A	Flare Type RT	N/A
N/A	Flare Slope LT (%)	N/A	N/A	Flare Slope RT (%)	N/A
N/A	Flare Traversable LT?	N/A	N/A	Flare Traversable RT?	N/A
Yes	Landing Length (in)	49.0	Yes	DWS Provided?	Yes
Yes	Landing Width (in)	48.0	Yes	DWS Contrast?	Yes
No	Landing Slope (%)	5.5	Yes	DWS Length (in)	24.0
Yes	Landing X Slope (%)	0.0	Yes	DWS Full Width?	Yes
N/A	Landing Curb? (Y/N)	No	No	DWS Offset LT (in)	29.0
N/A	Shared Landing?	No	No	DWS Offset RT (in)	80.0
Yes	Gutter Ponding?	No	Yes	Gutter Slope (%)	3.5
Yes	Gutter Lip Ht (in)	0.0	Yes	Gutter X Slope (%)	1.4
N/A	Painted X Walk1?	No		Road Slope (%)	4.9
	X Walk 1 Direction	To E		Road X Slope (%)	0.7
	X Walk 1 Width (in)	N/A		Clear Space?	Yes

X Walk 1 Slope (%)	4.9	N/A	Clear Space to XWalk (in)	N/A
	X Walk 1 X Slope (%)	0.7	Yes	Storm Grate/Utility Hazard?	No
N/A	Ramp inside XWalk1?	N/A		Storm Grate/Utility Type	
Yes	Any Obstructions?	No			N/A
	Obstruction Type		Yes	Surface Condition? (G/P)	Good
			N/A	Curb Slope (%)	0.9

Possible Solutions:

Remove & Replace Entire Ramp.
