Access Compliance Report

Public Rights-of-Way

(Curb Ramps)

Intersection ID: N/A	Main Street: REA_RD	Cross Street: CEDAR_CROFT_DR	Location: N
ADA ID: B4179D2F5842	Ramp Type: Perp	Initial Pass/Fail: Fail	Overall Compliance: No
Severity Score: 13.75			
Codes/Mitigation Info/Possible Solution		Field Measurements/Component Compliance

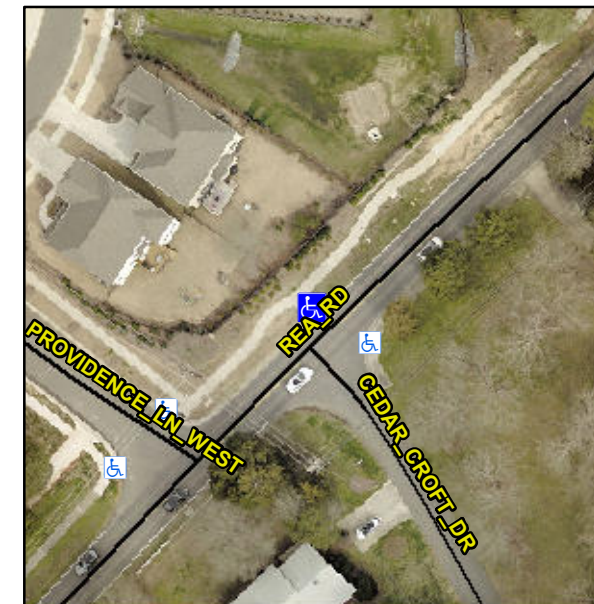
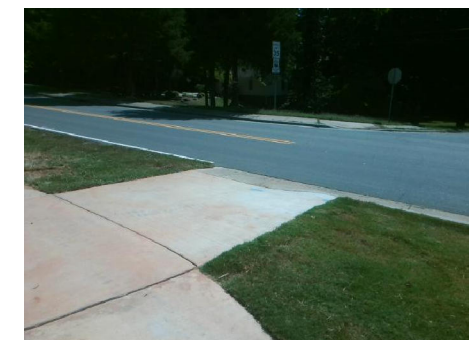
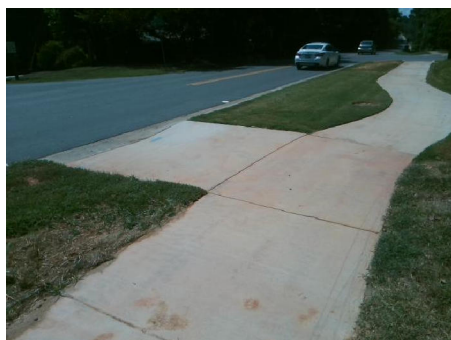
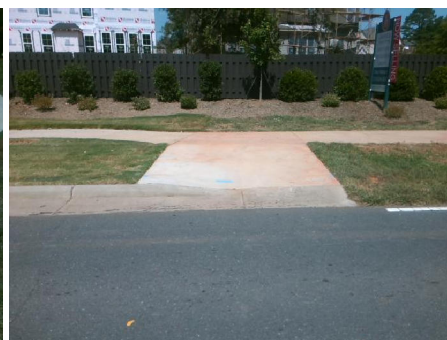
Not Found, R304.2.2, R304.5.3

Compliance	Description	Data	Compliance	Description	Data
N/A	Ramp Length (in)	103.0	No	Ramp Slope (%)	11.7
Yes	Ramp Width (in)	48.0	No	Ramp XSlope (%)	3.1
N/A	Flare Type LT	N/A	N/A	Flare Type RT	N/A
N/A	Flare Slope LT (%)	N/A	N/A	Flare Slope RT (%)	N/A
N/A	Flare Traversable LT?	N/A	N/A	Flare Traversable RT?	N/A
N/A	Landing Length (in)	N/A	N/A	DWS Provided?	N/A
N/A	Landing Width (in)	N/A	N/A	DWS Contrast?	N/A
N/A	Landing Slope (%)	N/A	N/A	DWS Length (in)	N/A
N/A	Landing X Slope (%)	N/A	N/A	DWS Full Width?	N/A
N/A	Landing Curb? (Y/N)	N/A	N/A	DWS Offset (in)	N/A
N/A	Shared Landing?	N/A			
N/A	Gutter Ponding?	N/A	N/A	Gutter Slope (%)	N/A
N/A	Gutter Lip Ht (in)	N/A	N/A	Gutter X Slope (%)	N/A
N/A	Painted X Walk1?	No	N/A	Painted X Walk2?	N/A
	X Walk 1 Direction	To SE		X Walk 2 Direction	N/A
N/A	X Walk 1 Width (in)	N/A	N/A	X Walk 2 Width (in)	N/A
	X Walk 1 Slope (%)	0.9		X Walk 2 Slope (%)	N/A
	X Walk 1 X Slope (%)	1.7		X Walk 2 X Slope (%)	N/A

N/A	Ramp inside XWalk1?	N/A	N/A	Ramp inside XWalk2?	N/A
	Road Slope (%)	N/A	N/A	Clear Space?	N/A
	Road X Slope (%)	N/A	N/A	Clear Space to XWalk (in)	N/A
N/A	Any Obstructions?	N/A	N/A	Storm Grate/Utility Hazard?	N/A
	Obstruction Type			Storm Grate/Utility Type	
		N/A			N/A
			Yes	Surface Condition? (G/P)	Good

Remove & Replace Entire Ramp.

Total Cost: \$ 1850.00
