Access Compliance Report

Public Rights-of-Way

(Curb Ramps)

Intersection ID: 8157	Main Street: N_TRYON_ST	Cross Street: ORR_RD	Location: NE
ADA ID: B417D5434EE2	Ramp Type: Perp	Initial Pass/Fail: Pass	Overall Compliance: No
Severity Score: 0			
Codes/Mitigation Info/Possible Solution		Field Measurements/Component Compliance

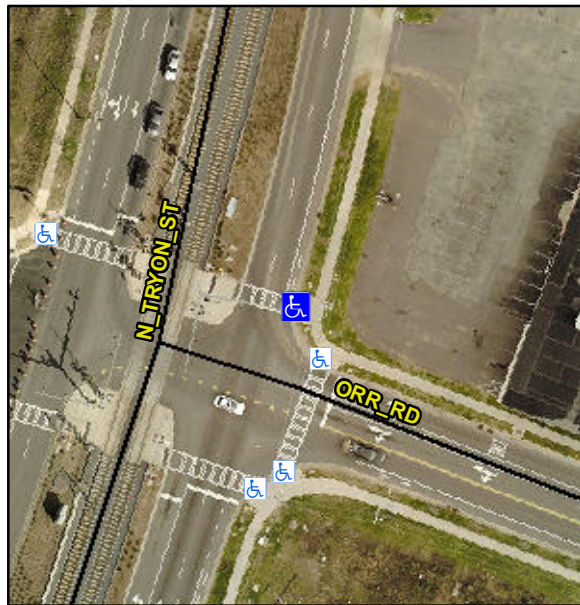
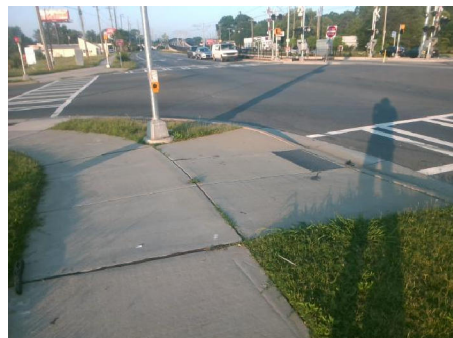
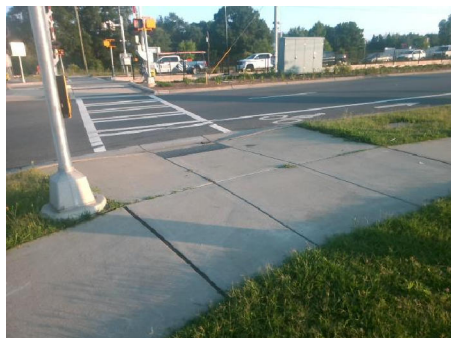
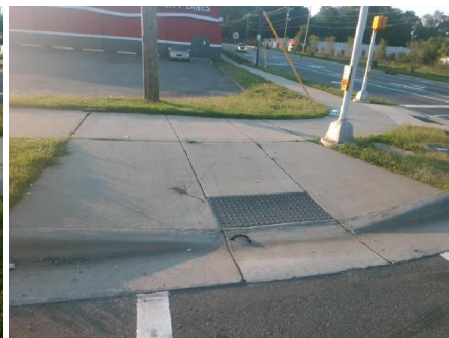
Compliance	Description	Data	Compliance	Description	Data
N/A	Ramp Length (in)	96.0	Yes	Ramp Slope (%)	7.4
Yes	Ramp Width (in)	48.5	Yes	Ramp XSlope (%)	1.2
N/A	Flare Type LT	Sloped	N/A	Flare Type RT	N/A
N/A	Flare Slope LT (%)	8.1	N/A	Flare Slope RT (%)	6.3
N/A	Flare Traversable LT?	No	N/A	Flare Traversable RT?	No
Yes	Landing Length (in)	71.0	Yes	DWS Provided?	Yes
Yes	Landing Width (in)	48.0	Yes	DWS Contrast?	Yes
Yes	Landing Slope (%)	0.4	Yes	DWS Length (in)	24.0
No	Landing X Slope (%)	2.1	Yes	DWS Full Width?	Yes
N/A	Landing Curb? (Y/N)	No	Yes	DWS Offset (in)	2.0
N/A	Shared Landing?	No			
No	Gutter Ponding?	Yes	Yes	Gutter Slope (%)	3.4
Yes	Gutter Lip Ht (in)	0.0	No	Gutter X Slope (%)	2.1
N/A	Painted X Walk1?	Yes	N/A	Painted X Walk2?	N/A
	X Walk 1 Direction	To W		X Walk 2 Direction	N/A
N/A	X Walk 1 Width (in)	97.0	N/A	X Walk 2 Width (in)	N/A
	X Walk 1 Slope (%)	3.3		X Walk 2 Slope (%)	N/A
	X Walk 1 X Slope (%)	1.1		X Walk 2 X Slope (%)	N/A

Yes	Ramp inside XWalk1?	Yes	N/A	Ramp inside XWalk2?	N/A
	Road Slope (%)	N/A	N/A	Clear Space?	Yes
	Road X Slope (%)	N/A	N/A	Clear Space to XWalk (in)	N/A
Yes	Any Obstructions?	No	Yes	Storm Grate/Utility Hazard?	No
	Obstruction Type			Storm Grate/Utility Type	
		N/A			N/A
			Yes	Surface Condition? (G/P)	Good

**Remove & Replace Landing.
Remove & Replace Gutter.**

R304.5.3, R302.7
