Access Compliance Report

Public Rights-of-Way

(Curb Ramps)

Intersection ID: 12027	Main Street: S_SUMMIT_AV	Cross Street: W_MOREHEAD_ST	Location: SE
ADA ID: B41F23740A1C	Ramp Type: BlendTrans1	Initial Pass/Fail: Fail	Overall Compliance: No
		Severity Score: 17.5

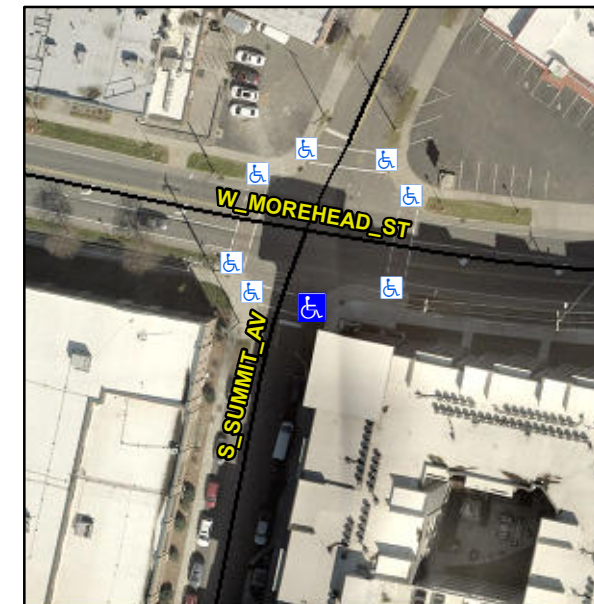
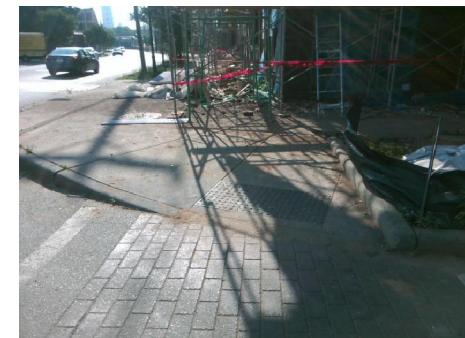
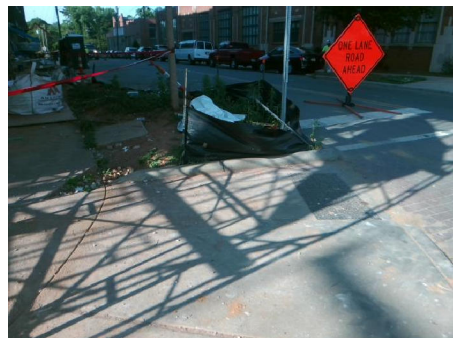
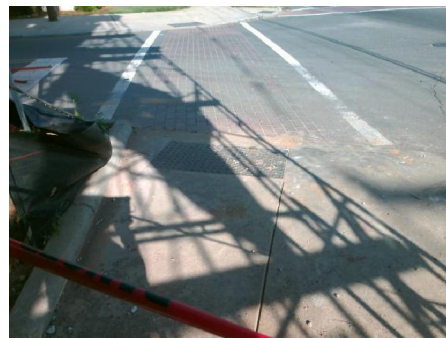
Not Found, R304.5.1

Compliance	Description	Data	Compliance	Description	Data
N/A	Ramp Length (in)	105.0	Yes	BlendTrans Slope (%)	3.0
No	Ramp Width (in)	33.0	Yes	BlendTrans XSlope (%)	0.1
N/A	Flare Type LT	N/A	N/A	Flare Type RT	N/A
N/A	Flare Slope LT (%)	N/A	N/A	Flare Slope RT (%)	N/A
N/A	Flare Traversable LT?	N/A	N/A	Flare Traversable RT?	N/A
N/A	Landing Length (in)	N/A	N/A	DWS Provided?	N/A
N/A	Landing Width (in)	N/A	N/A	DWS Contrast?	N/A
N/A	Landing Slope (%)	N/A	N/A	DWS Length (in)	N/A
N/A	Landing X Slope (%)	N/A	N/A	DWS Full Width?	N/A
N/A	Landing Curb? (Y/N)	N/A	N/A	DWS Offset (in)	N/A
N/A	Shared Landing?	N/A			
N/A	Gutter Ponding?	N/A	N/A	Gutter Slope (%)	N/A
N/A	Gutter Lip Ht (in)	N/A	N/A	Gutter X Slope (%)	N/A
N/A	Painted X Walk1?	Yes	N/A	Painted X Walk2?	N/A
	X Walk 1 Direction	To W		X Walk 2 Direction	N/A
	X Walk 1 Width (in)	104.0		X Walk 2 Width (in)	N/A
	X Walk 1 Slope (%)	2.4		X Walk 2 Slope (%)	N/A
	X Walk 1 X Slope (%)	0.2		X Walk 2 X Slope (%)	N/A

N/A	Ramp inside XWalk1?	Yes	N/A	Ramp inside XWalk2?	N/A
	Road Slope (%)	0.2		Clear Space?	N/A
	Road X Slope (%)	2.4	N/A	Clear Space to XWalk (in)	N/A
N/A	Any Obstructions?	N/A	N/A	Storm Grate/Utility Hazard?	N/A
	Obstruction Type			Storm Grate/Utility Type	
		N/A			N/A
			Yes	Surface Condition? (G/P)	Good
			No	Curb Slope (%)	5.8

Remove & Replace Curb Ramp With Two New Directional Ramps or Equivalent.

Total Cost: \$ 3200.00
