Access Compliance Report

Public Rights-of-Way

(Curb Ramps)

Intersection ID: 10022963	Main Street: CEDAR_WALK_LN	Cross Street: N/A	Location: S
ADA ID: B41F3EDBF09A	Ramp Type: BlendTrans1	Initial Pass/Fail: Fail	Overall Compliance: No
		Severity Score: 60

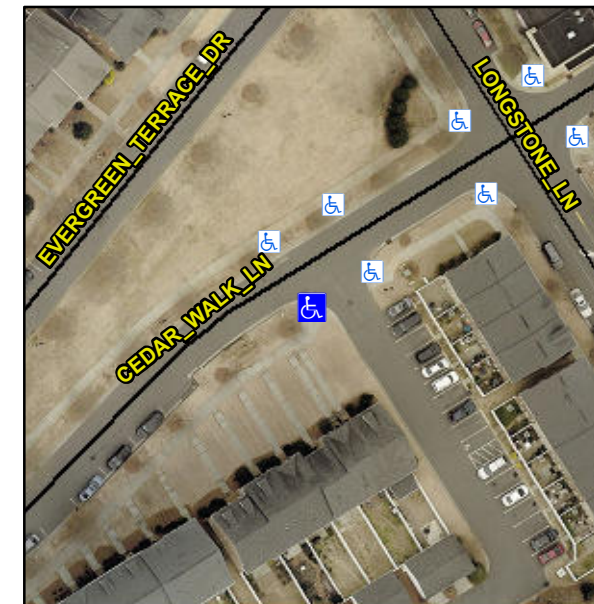
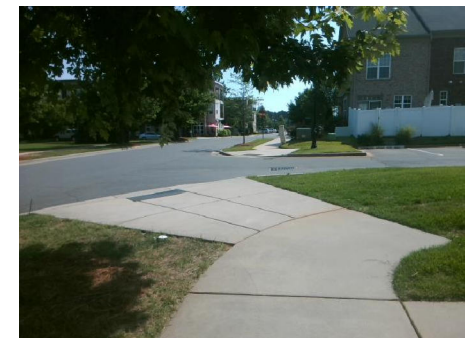
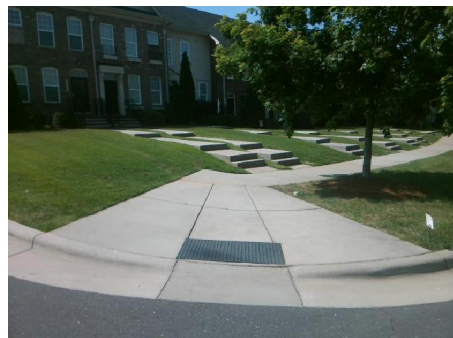
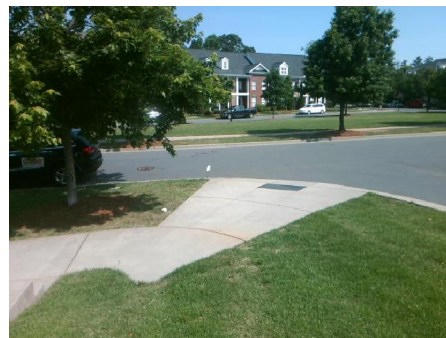
Not Found, R304.5.1, R304.5.3

Compliance	Description	Data	Compliance	Description	Data
N/A	Ramp Length (in)	163.5	Yes	BlendTrans Slope (%)	3.8
No	Ramp Width (in)	27.5	No	BlendTrans XSlope (%)	7.2
N/A	Flare Type LT	N/A	N/A	Flare Type RT	N/A
N/A	Flare Slope LT (%)	N/A	N/A	Flare Slope RT (%)	N/A
N/A	Flare Traversable LT?	N/A	N/A	Flare Traversable RT?	N/A
N/A	Landing Length (in)	N/A	N/A	DWS Provided?	N/A
N/A	Landing Width (in)	N/A	N/A	DWS Contrast?	N/A
N/A	Landing Slope (%)	N/A	N/A	DWS Length (in)	N/A
N/A	Landing X Slope (%)	N/A	N/A	DWS Full Width?	N/A
N/A	Landing Curb? (Y/N)	N/A	N/A	DWS Offset (in)	N/A
N/A	Shared Landing?	N/A			
N/A	Gutter Ponding?	N/A	N/A	Gutter Slope (%)	N/A
N/A	Gutter Lip Ht (in)	N/A	N/A	Gutter X Slope (%)	N/A
N/A	Painted X Walk1?	No	N/A	Painted X Walk2?	No
	X Walk 1 Direction	To NE		X Walk 2 Direction	To NW
	X Walk 1 Width (in)	N/A		X Walk 2 Width (in)	N/A
	X Walk 1 Slope (%)	0.9		X Walk 2 Slope (%)	1.4
	X Walk 1 X Slope (%)	2.6		X Walk 2 X Slope (%)	3.0

N/A	Ramp inside XWalk1?	N/A	N/A	Ramp inside XWalk2?	N/A
	Road Slope (%)	4.7		Clear Space?	N/A
	Road X Slope (%)	0.4	N/A	Clear Space to XWalk (in)	N/A
N/A	Any Obstructions?	N/A	N/A	Storm Grate/Utility Hazard?	N/A
	Obstruction Type			Storm Grate/Utility Type	
		N/A			N/A
			Yes	Surface Condition? (G/P)	Good
			No	Curb Slope (%)	19.2

Remove & Replace Curb Ramp With Two New Directional Ramps or Equivalent.
