# Access Compliance Report

## Public Rights-of-Way

### (Curb Ramps)

Intersection ID: 32302	Main Street: HAZELVIEW_DR	Cross Street: HONEYNUT_DR	Location:	NW
ADA ID: B42162DD6465	Ramp Type: PerpDiag	Initial Pass/Fail: Fail	Overall Compliance: No	Severity Score: 25
Codes/Mitigation Info/Possible Solution		Field Measurements/Component Compliance

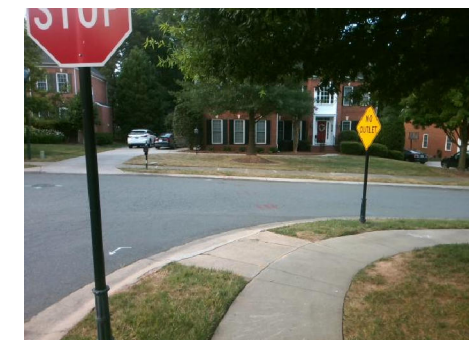
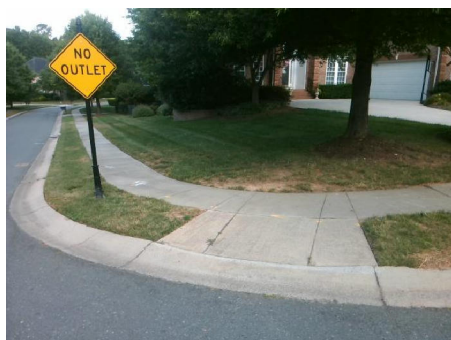
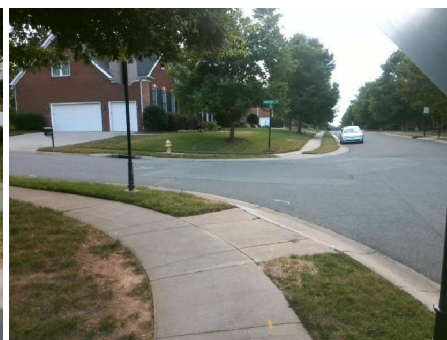
Compliance	Description	Data	Compliance	Description	Data
N/A	Ramp Length (in)	50.0	Yes	Ramp Slope (%)	5.3
Yes	Ramp Width (in)	48.0	No	Ramp XSlope (%)	7.1
N/A	Flare Type LT	N/A	N/A	Flare Type RT	N/A
N/A	Flare Slope LT (%)	N/A	N/A	Flare Slope RT (%)	N/A
N/A	Flare Traversable LT?	N/A	N/A	Flare Traversable RT?	N/A
N/A	Landing Length (in)	N/A	N/A	DWS Provided?	N/A
N/A	Landing Width (in)	N/A	N/A	DWS Contrast?	N/A
N/A	Landing Slope (%)	N/A	N/A	DWS Length (in)	N/A
N/A	Landing X Slope (%)	N/A	N/A	DWS Full Width?	N/A
N/A	Landing Curb? (Y/N)	N/A	N/A	DWS Offset (in)	N/A
N/A	Shared Landing?	N/A			
N/A	Gutter Ponding?	N/A	N/A	Gutter Slope (%)	N/A
N/A	Gutter Lip Ht (in)	N/A	N/A	Gutter X Slope (%)	N/A
N/A	Painted X Walk1?	No	N/A	Painted X Walk2?	No
	X Walk 1 Direction	To S		X Walk 2 Direction	To E
N/A	X Walk 1 Width (in)	N/A	N/A	X Walk 2 Width (in)	N/A
	X Walk 1 Slope (%)	1.5		X Walk 2 Slope (%)	6.0
	X Walk 1 X Slope (%)	6.5		X Walk 2 X Slope (%)	0.5

N/A	Ramp inside XWalk1?	N/A	N/A	Ramp inside XWalk2?	N/A
	Road Slope (%)	5.4	N/A	Clear Space?	N/A
	Road X Slope (%)	6.1	N/A	Clear Space to XWalk (in)	N/A
N/A	Any Obstructions?	N/A	N/A	Storm Grate/Utility Hazard?	N/A
	Obstruction Type			Storm Grate/Utility Type	
		N/A			N/A
			Yes	Surface Condition? (G/P)	Good

**Remove & Replace Curb Ramp With Two New Directional Ramps or Equivalent.**
