Access Compliance Report

Public Rights-of-Way

(Curb Ramps)

Intersection ID: 18408	Main Street: REDCOAT_DR	Cross Street: LYNBROOK_DR	Location: NE
ADA ID: B425C12FFD36	Ramp Type: PerpDiag	Initial Pass/Fail: Fail	Overall Compliance: No
			Severity Score: 21.25

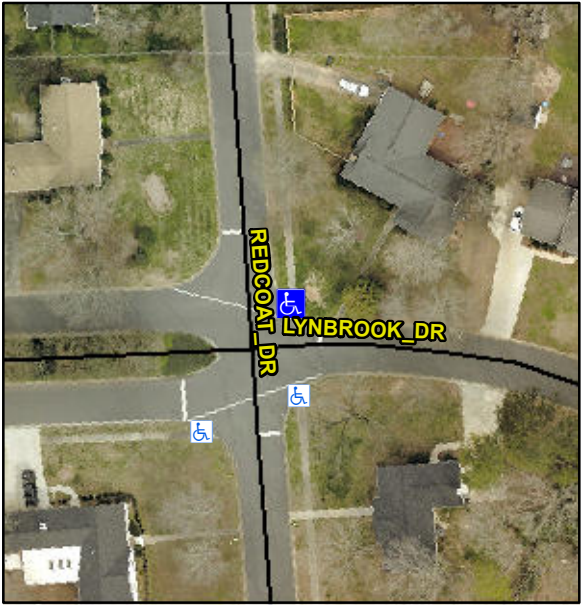
Possible Solutions:						
	Remove & Replace Curb Ramp With Two New Directional Ramps or Equivalent.						
	Surveyor Notes:						
	N/A						
	PROW/ADA:						
	Not Found, R304.5.1, R304.2.2						
		Compliance	Description	Data	Compliance	Description	Data
		N/A	Ramp Length (in)	48.0	No	Ramp Slope (%)	9.9
		No	Ramp Width (in)	45.5	Yes	Ramp XSlope (%)	1.7
		N/A	Flare Type LT	N/A	N/A	Flare Type RT	N/A
		N/A	Flare Slope LT (%)	N/A	N/A	Flare Slope RT (%)	N/A
		N/A	Flare Traversable LT?	N/A	N/A	Flare Traversable RT?	N/A
		N/A	Landing Length (in)	N/A	N/A	DWS Provided?	N/A
		N/A	Landing Width (in)	N/A	N/A	DWS Contrast?	N/A
		N/A	Landing Slope (%)	N/A	N/A	DWS Length (in)	N/A
		N/A	Landing X Slope (%)	N/A	N/A	DWS Full Width?	N/A
		N/A	Landing Curb? (Y/N)	N/A	N/A	DWS Offset (in)	N/A
		N/A	Shared Landing?	N/A			
		N/A	Gutter Ponding?	N/A	N/A	Gutter Slope (%)	N/A

N/A	Gutter Lip Ht (in)	N/A	N/A	Gutter X Slope (%)	N/A
		N/A	Painted X Walk1?	No	N/A	Painted X Walk2?	No
			X Walk 1 Direction	To S		X Walk 2 Direction	To W
		N/A	X Walk 1 Width (in)	N/A	N/A	X Walk 2 Width (in)	N/A
			X Walk 1 Slope (%)	4.7		X Walk 2 Slope (%)	3.3
			X Walk 1 X Slope (%)	2.1		X Walk 2 X Slope (%)	1.4
		N/A	Ramp inside XWalk1?	N/A	N/A	Ramp inside XWalk2?	N/A
			Road Slope (%)	0.5	N/A	Clear Space?	N/A
			Road X Slope (%)	5.0	N/A	Clear Space to XWalk (in)	N/A
		N/A	Any Obstructions?	N/A	N/A	Storm Grate/Utility Hazard?	N/A
			Obstruction Type			Storm Grate/Utility Type	
				N/A			N/A
					Yes	Surface Condition? (G/P)	Good
Total Cost:		\$	3200.00

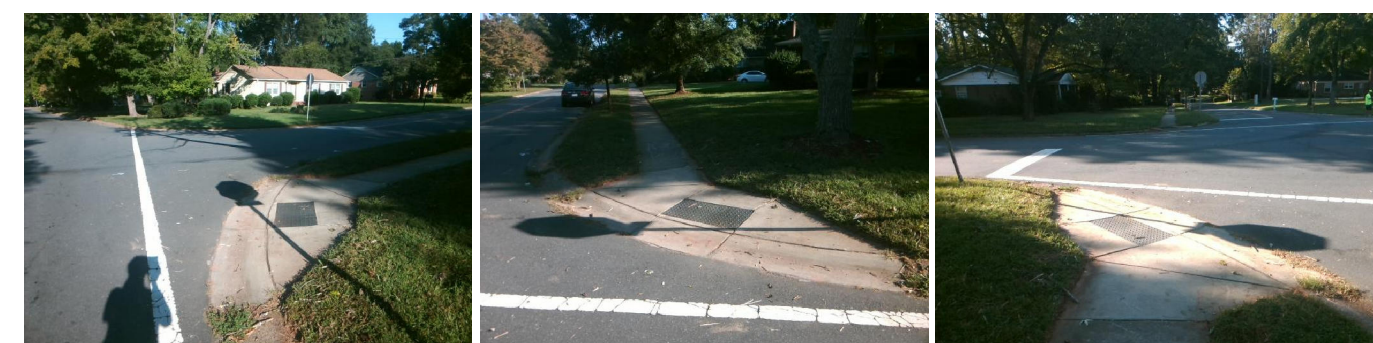
Street 1 Name	LYNBROOK DR
Stop Condition-Street 2	StopSign
Street 2 Name	REDCOAT DR
Stop Condition-Street 1	StopSign
