# Access Compliance Report

## Public Rights-of-Way

### (Curb Ramps)

Intersection ID: 54779	Main Street: SHARON AMITY RD	Cross Street: CHARLESTON DR	Location: E
ADA ID: B4371EA4C76A	Ramp Type: Perp	Initial Pass/Fail: Fail	Overall Compliance: No
Codes/Mitigation Info/Possible Solution		Field Measurements/Component Compliance	
Severity Score: 13.75

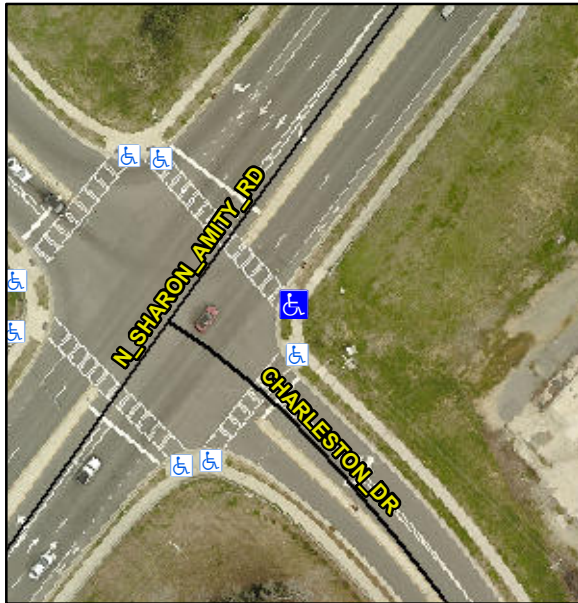
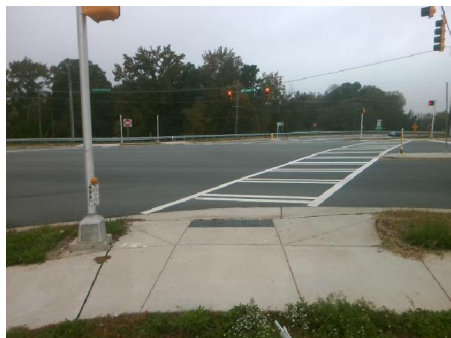
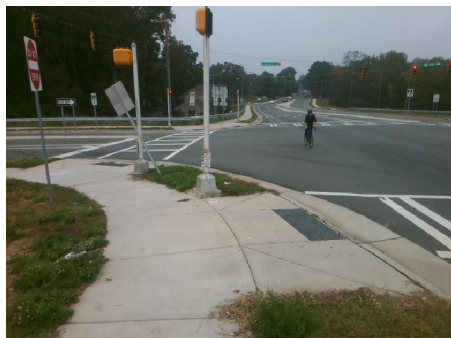
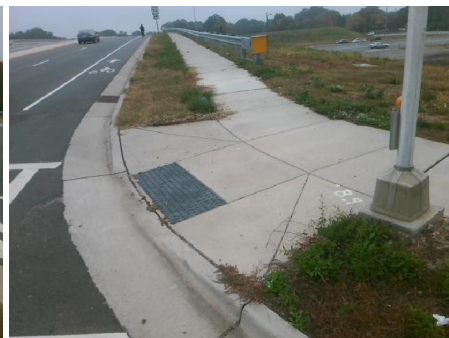
**R304.2.2**

Compliance	Description	Data	Compliance	Description	Data
N/A	Ramp Length (in)	65.0	No	Ramp Slope (%)	8.9
Yes	Ramp Width (in)	59.0	Yes	Ramp XSlope (%)	2.6
N/A	Flare Type LT	N/A	N/A	Flare Type RT	N/A
N/A	Flare Slope LT (%)	N/A	N/A	Flare Slope RT (%)	N/A
N/A	Flare Traversable LT?	N/A	N/A	Flare Traversable RT?	N/A
N/A	Landing Length (in)	N/A	N/A	DWS Provided?	N/A
N/A	Landing Width (in)	N/A	N/A	DWS Contrast?	N/A
N/A	Landing Slope (%)	N/A	N/A	DWS Length (in)	N/A
N/A	Landing X Slope (%)	N/A	N/A	DWS Full Width?	N/A
N/A	Landing Curb? (Y/N)	N/A	N/A	DWS Offset (in)	N/A
N/A	Shared Landing?	N/A			
N/A	Gutter Ponding?	N/A	N/A	Gutter Slope (%)	N/A
N/A	Gutter Lip Ht (in)	N/A	N/A	Gutter X Slope (%)	N/A
N/A	Painted X Walk1?	Yes	N/A	Painted X Walk2?	N/A
	X Walk 1 Direction	To NW		X Walk 2 Direction	N/A
N/A	X Walk 1 Width (in)	112.0	N/A	X Walk 2 Width (in)	N/A
	X Walk 1 Slope (%)	2.7		X Walk 2 Slope (%)	N/A
	X Walk 1 X Slope (%)	5.5		X Walk 2 X Slope (%)	N/A

N/A	Ramp inside XWalk1?	Yes	N/A	Ramp inside XWalk2?	N/A
	Road Slope (%)	N/A	N/A	Clear Space?	N/A
	Road X Slope (%)	N/A	N/A	Clear Space to XWalk (in)	N/A
N/A	Any Obstructions?	N/A	N/A	Storm Grate/Utility Hazard?	N/A
	Obstruction Type			Storm Grate/Utility Type	
		N/A			N/A
		Yes		Surface Condition? (G/P)	Good

**Remove & Replace Entire Ramp.**

Total Cost: \$ 1850.00
