# Access Compliance Report

## Public Rights-of-Way

### (Curb Ramps)

| Intersection ID: 7793 | Main Street: JEFF_ADAMS_DR | Cross Street: STATESVILLE_AV | Location: NW |

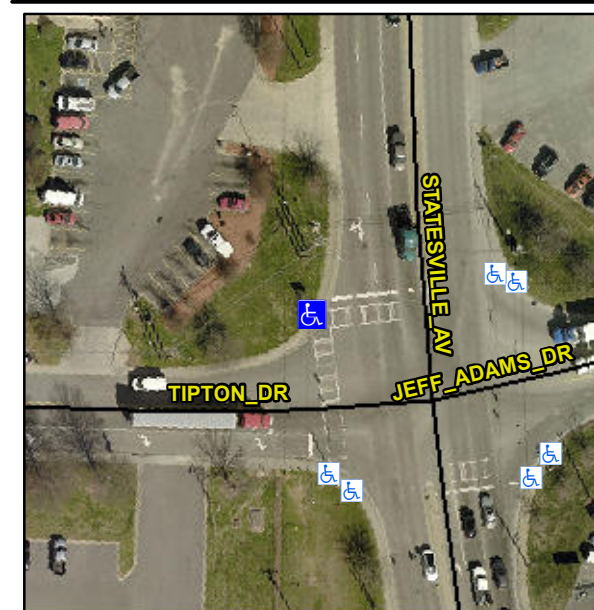
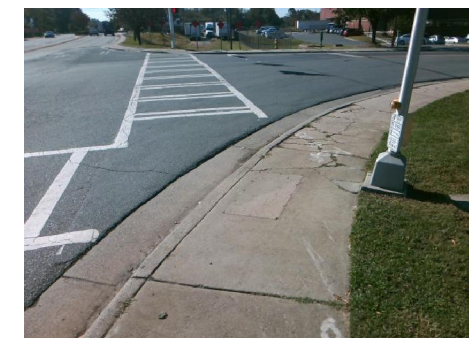
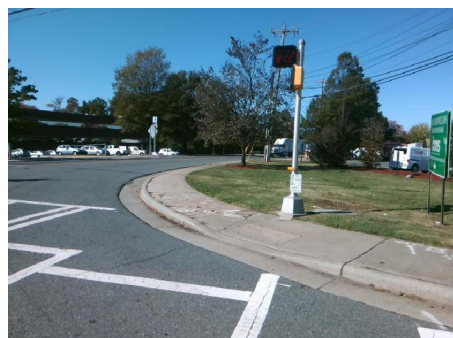
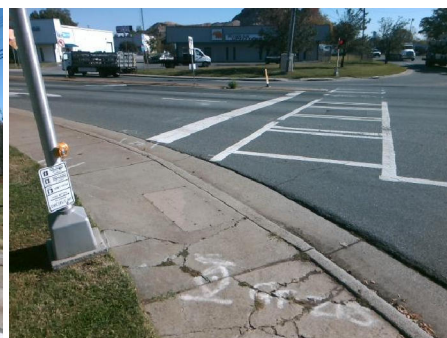
**Not Found, R304.5.3, R304.2.1, R304.2.2-Perp, R304.3.2-Para, R305, R302.7.2, R304.5.4**

| Compliance | Description | Data | Compliance | Description | Data |
|---|---|---|---|---|---|
| Yes | Ramp Width (in) | 48.0 | No | Ramp XSlope (%) | 2.3 |
| No | Landing Length (in) | N/A | No | DWS Provided? | No |
| No | Landing X Slope (%) | N/A | N/A | DWS Full Width? | No |
| Yes | Gutter Ponding? | No | No | Gutter Slope (%) | 6.9 |
| No | Gutter Lip Ht (in) | 1.0 | Yes | Gutter X Slope (%) | 1.9 |

**Remove & Replace Curb Ramp With Two New Directional Ramps or Equivalent. Remove & Replace Gutter.**

Total Cost: \$ **3950.00**
