Access Compliance Report

Public Rights-of-Way

(Curb Ramps)

Intersection ID: 4194	Main Street: COLVARD_PARK_WY	Cross Street: MALLARD_CREEK_RD	Location: SW
ADA ID: B464076610D9	Ramp Type: Perp	Initial Pass/Fail: Fail	Overall Compliance: No
			Severity Score: 21.25

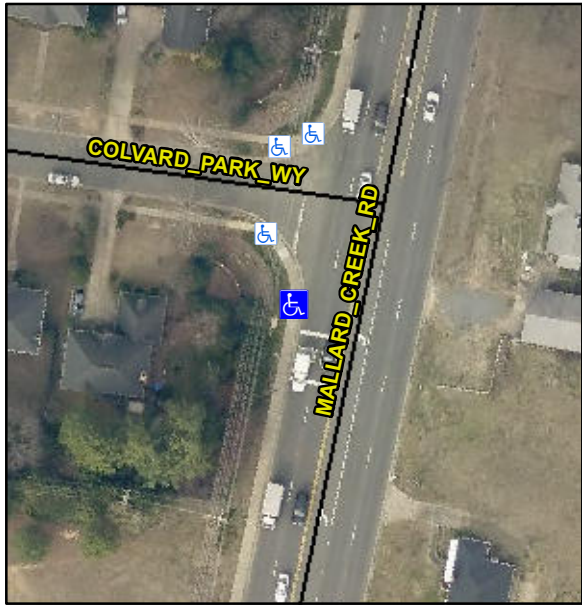
Possible Solutions:		Compliance	Description	Data	Compliance	Description	Data
	Remove & Replace Entire Ramp.		N/A	Ramp Length (in)	64.0	No	Ramp Slope (%)	8.4
			No	Ramp Width (in)	42.5	Yes	Ramp XSlope (%)	1.6
			N/A	Flare Type LT	N/A	N/A	Flare Type RT	N/A
			N/A	Flare Slope LT (%)	N/A	N/A	Flare Slope RT (%)	N/A
			N/A	Flare Traversable LT?	N/A	N/A	Flare Traversable RT?	N/A
			N/A	Landing Length (in)	N/A	N/A	DWS Provided?	N/A
			N/A	Landing Width (in)	N/A	N/A	DWS Contrast?	N/A
			N/A	Landing Slope (%)	N/A	N/A	DWS Length (in)	N/A
			N/A	Landing X Slope (%)	N/A	N/A	DWS Full Width?	N/A
<p>Surveyor Notes:</p> <p>N/A</p> <p>PROW/ADA:</p> <p>R304.5.1, R304.2.2</p>			N/A	Landing Curb? (Y/N)	N/A	N/A	DWS Offset (in)	N/A
			N/A	Shared Landing?	N/A			
			N/A	Gutter Ponding?	N/A	N/A	Gutter Slope (%)	N/A
			N/A	Gutter Lip Ht (in)	N/A	N/A	Gutter X Slope (%)	N/A

N/A	Painted X Walk1?	No	N/A	Painted X Walk2?	N/A
				X Walk 1 Direction	To E		X Walk 2 Direction	N/A
			N/A	X Walk 1 Width (in)	N/A	N/A	X Walk 2 Width (in)	N/A
				X Walk 1 Slope (%)	0.6		X Walk 2 Slope (%)	N/A
				X Walk 1 X Slope (%)	1.1		X Walk 2 X Slope (%)	N/A
			N/A	Ramp inside XWalk1?	N/A	N/A	Ramp inside XWalk2?	N/A
				Road Slope (%)	N/A	N/A	Clear Space?	N/A
				Road X Slope (%)	N/A	N/A	Clear Space to XWalk (in)	N/A
			N/A	Any Obstructions?	N/A	N/A	Storm Grate/Utility Hazard?	N/A
				Obstruction Type			Storm Grate/Utility Type	
					N/A			N/A
						Yes	Surface Condition? (G/P)	Good
	Total Cost:		\$	1850.00
