# Access Compliance Report

## Public Rights-of-Way

### (Curb Ramps)

| Intersection ID: 43075 | Main Street: SCOTT_AV | Cross Street: ROMANY_RD | Location: NW |

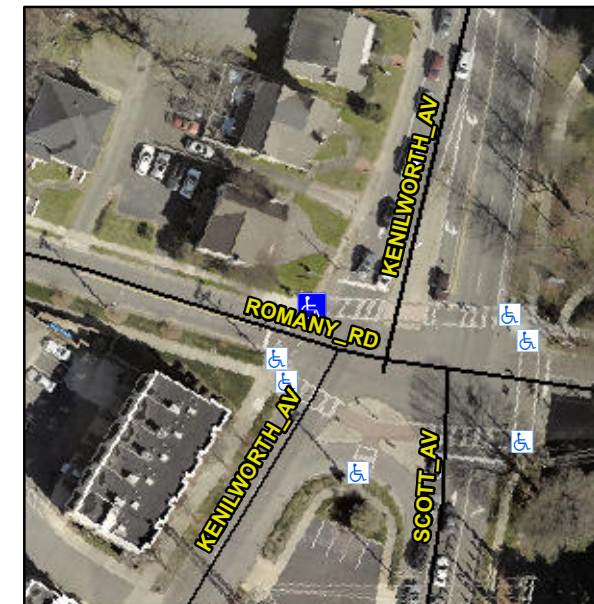
#### Field Measurements/Component Compliance

**Not Found, R304.2.2**

| Compliance | Description | Data | Compliance | Description | Data |
|---|---|---|---|---|---|
| N/A | Ramp Length (in) | 53.0 | No | Ramp Slope (%) | 9.4 |

**Remove & Replace Curb Ramp With Two New Directional Ramps or Equivalent.**
