# Access Compliance Report

## Public Rights-of-Way

### (Curb Ramps)

| Intersection ID: 14189 | Main Street: E_KINGSTON_AV | Cross Street: EUCLID_AV | Location: | N |

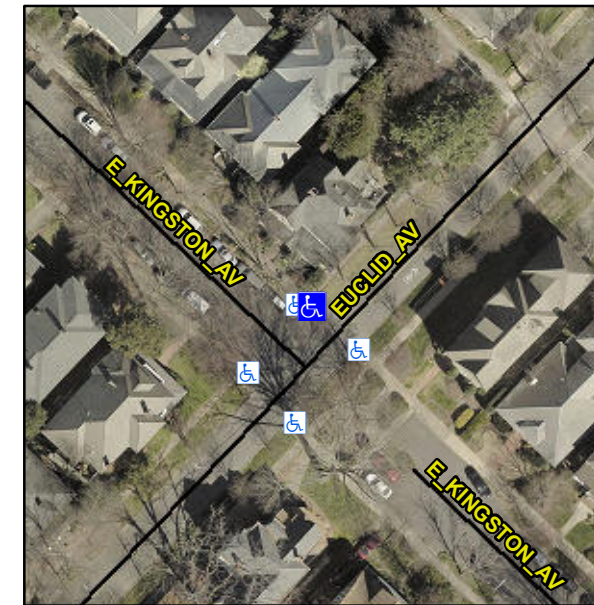
| ADA ID: B469BCCAAC52 | Ramp Type: Directional1 | Initial Pass/Fail: Pass | Overall Compliance: No | Severity Score: 30 |

| Compliance | Description | Data | Compliance | Description | Data |
|---|---|---|---|---|---|
| Yes | Landing Length (in) | 50.0 | No | DWS Provided? | No |
| No | Landing Slope (%) | 3.3 | N/A | DWS Length (in) | N/A |
| No | Landing X Slope (%) | 2.4 | N/A | DWS Full Width? | No |
| No | Gutter Ponding? | Yes | No | Gutter Slope (%) | 6.6 |
| No | Gutter Lip Ht (in) | 1.0 | No | Gutter X Slope (%) | 4.0 |

**Remove & Replace Entire Ramp.  
Remove & Replace Gutter.**
