# Access Compliance Report

## Public Rights-of-Way

### (Curb Ramps)

Intersection ID: 18263	Main Street: DRIFTER_DR	Cross Street: JALDEN DR	Location: SE
ADA ID: B47A3DB10970	Ramp Type: Perp	Initial Pass/Fail: Fail	Overall Compliance: No
Codes/Mitigation Info/Possible Solution		Field Measurements/Component Compliance	
Severity Score: 33.75

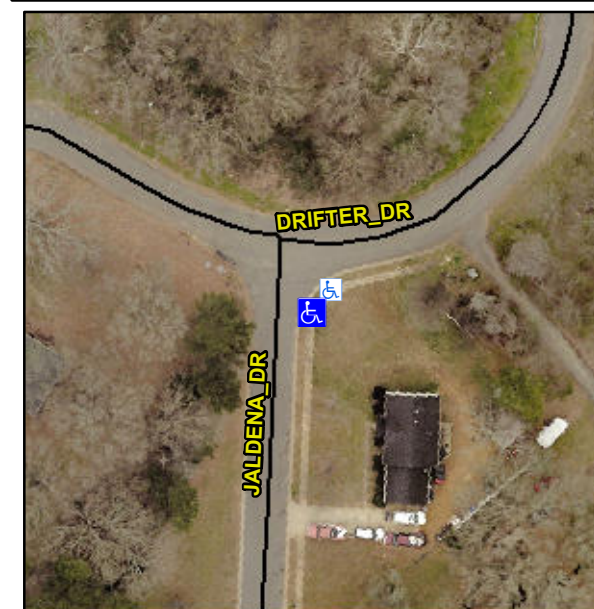
**Not Found, R304.5.1, R304.2.2, R304.5.3**

Compliance	Description	Data	Compliance	Description	Data
N/A	Ramp Length (in)	48.0	No	Ramp Slope (%)	10.3
No	Ramp Width (in)	45.0	No	Ramp XSlope (%)	6.2
N/A	Flare Type LT	N/A	N/A	Flare Type RT	N/A
N/A	Flare Slope LT (%)	N/A	N/A	Flare Slope RT (%)	N/A
N/A	Flare Traversable LT?	N/A	N/A	Flare Traversable RT?	N/A
N/A	Landing Length (in)	N/A	N/A	DWS Provided?	N/A
N/A	Landing Width (in)	N/A	N/A	DWS Contrast?	N/A
N/A	Landing Slope (%)	N/A	N/A	DWS Length (in)	N/A
N/A	Landing X Slope (%)	N/A	N/A	DWS Full Width?	N/A
N/A	Landing Curb? (Y/N)	N/A	N/A	DWS Offset (in)	N/A
N/A	Shared Landing?	N/A			
N/A	Gutter Ponding?	N/A	N/A	Gutter Slope (%)	N/A
N/A	Gutter Lip Ht (in)	N/A	N/A	Gutter X Slope (%)	N/A
N/A	Painted X Walk1?	No	N/A	Painted X Walk2?	N/A
	X Walk 1 Direction	To W		X Walk 2 Direction	N/A
N/A	X Walk 1 Width (in)	N/A	N/A	X Walk 2 Width (in)	N/A
	X Walk 1 Slope (%)	1.9		X Walk 2 Slope (%)	N/A
	X Walk 1 X Slope (%)	3.1		X Walk 2 X Slope (%)	N/A

**Remove & Replace Entire Ramp.**
