Access Compliance Report

Public Rights-of-Way

(Curb Ramps)

Intersection ID: 48583	Main Street: STONEY_CREEK_LN	Cross Street: WATERLILY_LN	Location: SW
ADA ID: B489889D0EEB	Ramp Type: PerpDiag	Initial Pass/Fail: Fail	Overall Compliance: No
Severity Score: 21.25			
Codes/Mitigation Info/Possible Solution		Field Measurements/Component Compliance

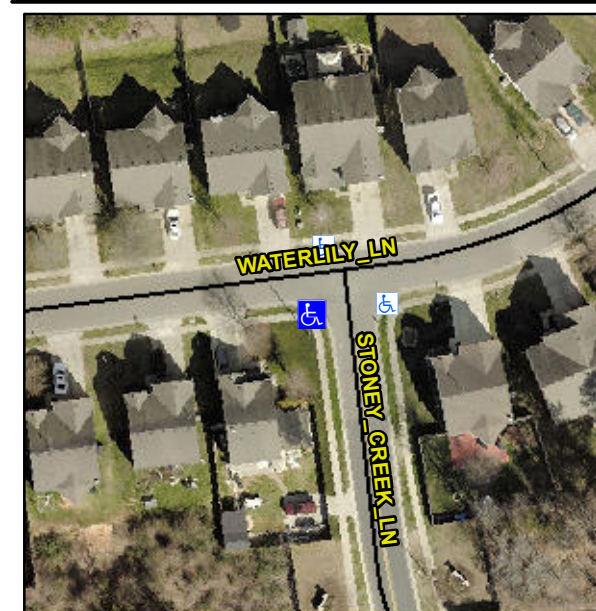
Not Found, R304.5.1, R304.2.2

Compliance	Description	Data	Compliance	Description	Data
N/A	Ramp Length (in)	47.5	No	Ramp Slope (%)	8.8
No	Ramp Width (in)	41.0	Yes	Ramp XSlope (%)	1.9
N/A	Flare Type LT	N/A	N/A	Flare Type RT	N/A
N/A	Flare Slope LT (%)	N/A	N/A	Flare Slope RT (%)	N/A
N/A	Flare Traversable LT?	N/A	N/A	Flare Traversable RT?	N/A
N/A	Landing Length (in)	N/A	N/A	DWS Provided?	N/A
N/A	Landing Width (in)	N/A	N/A	DWS Contrast?	N/A
N/A	Landing Slope (%)	N/A	N/A	DWS Length (in)	N/A
N/A	Landing X Slope (%)	N/A	N/A	DWS Full Width?	N/A
N/A	Landing Curb? (Y/N)	N/A	N/A	DWS Offset (in)	N/A
N/A	Shared Landing?	N/A			
N/A	Gutter Ponding?	N/A	N/A	Gutter Slope (%)	N/A
N/A	Gutter Lip Ht (in)	1.0	N/A	Gutter X Slope (%)	N/A
N/A	Painted X Walk1?	No	N/A	Painted X Walk2?	No
	X Walk 1 Direction	To E		X Walk 2 Direction	To N
N/A	X Walk 1 Width (in)	N/A	N/A	X Walk 2 Width (in)	N/A
	X Walk 1 Slope (%)	0.2		X Walk 2 Slope (%)	3.6
	X Walk 1 X Slope (%)	2.0		X Walk 2 X Slope (%)	0.0

N/A	Ramp inside XWalk1?	N/A	N/A	Ramp inside XWalk2?	N/A
	Road Slope (%)	2.3	N/A	Clear Space?	N/A
	Road X Slope (%)	1.2	N/A	Clear Space to XWalk (in)	N/A
N/A	Any Obstructions?	N/A	N/A	Storm Grate/Utility Hazard?	N/A
	Obstruction Type			Storm Grate/Utility Type	
		N/A			N/A
		Yes		Surface Condition? (G/P)	Good

Possible Solutions:

Remove & Replace Curb Ramp With Two New Directional Ramps or Equivalent.
