Access Compliance Report

Public Rights-of-Way

(Curb Ramps)

Intersection ID: 10035670	Main Street: RED_RUST_LN	Cross Street: N/A	Location: SE
ADA ID: B4A2E67B931A	Ramp Type: Perp	Initial Pass/Fail: Fail	Overall Compliance: No
Severity Score: 21.25			
Codes/Mitigation Info/Possible Solution		Field Measurements/Component Compliance

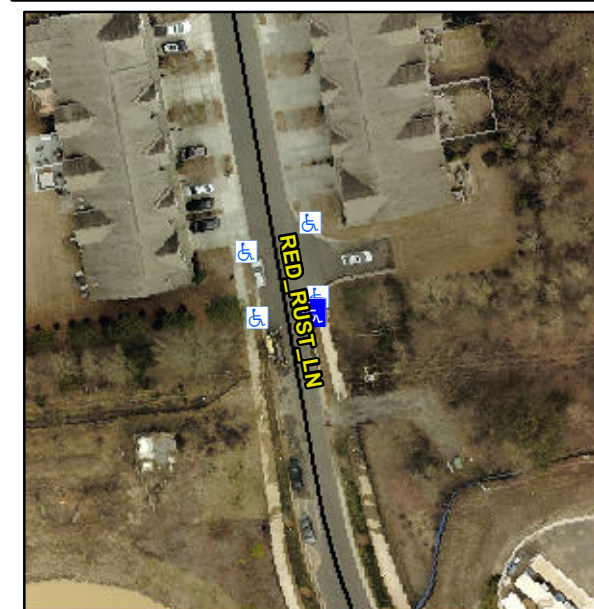
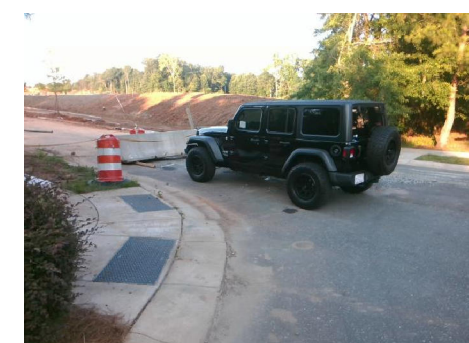
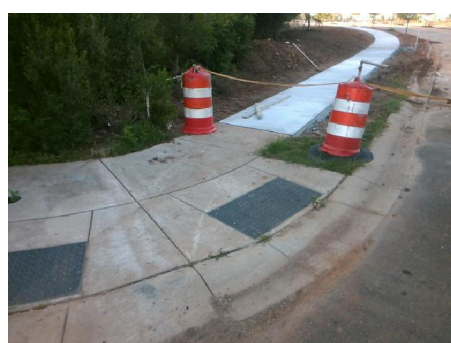
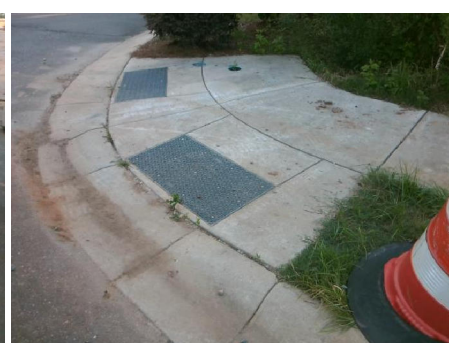
Compliance	Description	Data	Compliance	Description	Data
N/A	Ramp Length (in)	62.0	No	Ramp Slope (%)	8.4
No	Ramp Width (in)	47.5	Yes	Ramp XSlope (%)	0.9
N/A	Flare Type LT	N/A	N/A	Flare Type RT	N/A
N/A	Flare Slope LT (%)	N/A	N/A	Flare Slope RT (%)	N/A
N/A	Flare Traversable LT?	N/A	N/A	Flare Traversable RT?	N/A
N/A	Landing Length (in)	N/A	N/A	DWS Provided?	N/A
N/A	Landing Width (in)	N/A	N/A	DWS Contrast?	N/A
N/A	Landing Slope (%)	N/A	N/A	DWS Length (in)	N/A
N/A	Landing X Slope (%)	N/A	N/A	DWS Full Width?	N/A
N/A	Landing Curb? (Y/N)	N/A	N/A	DWS Offset (in)	N/A
N/A	Shared Landing?	N/A			
N/A	Gutter Ponding?	N/A	N/A	Gutter Slope (%)	N/A
N/A	Gutter Lip Ht (in)	N/A	N/A	Gutter X Slope (%)	N/A
N/A	Painted X Walk1?	No	N/A	Painted X Walk2?	N/A
	X Walk 1 Direction	To W		X Walk 2 Direction	N/A
N/A	X Walk 1 Width (in)	N/A	N/A	X Walk 2 Width (in)	N/A
	X Walk 1 Slope (%)	2.7		X Walk 2 Slope (%)	N/A
	X Walk 1 X Slope (%)	0.4		X Walk 2 X Slope (%)	N/A

N/A	Ramp inside XWalk1?	N/A	N/A	Ramp inside XWalk2?	N/A
	Road Slope (%)	N/A	N/A	Clear Space?	N/A
	Road X Slope (%)	N/A	N/A	Clear Space to XWalk (in)	N/A
N/A	Any Obstructions?	N/A	N/A	Storm Grate/Utility Hazard?	N/A
	Obstruction Type			Storm Grate/Utility Type	
		N/A			N/A
			Yes	Surface Condition? (G/P)	Good

Possible Solutions:

Remove & Replace Entire Ramp.

R304.5.1, R304.2.2
