Access Compliance Report

Public Rights-of-Way

(Curb Ramps)

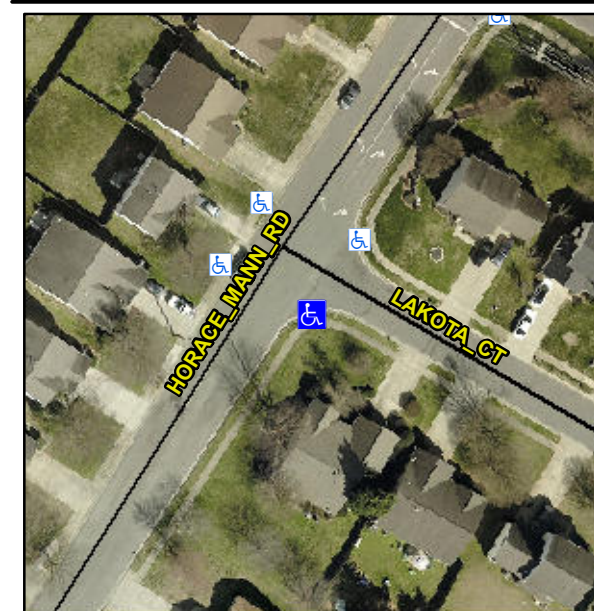
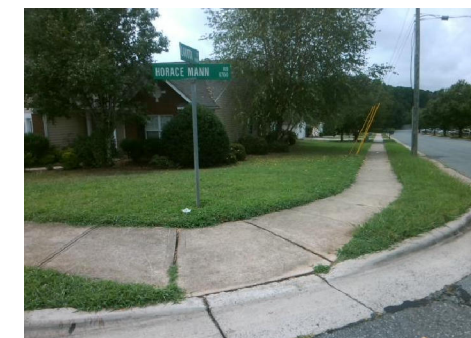
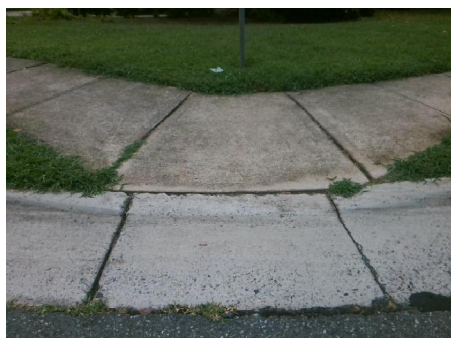
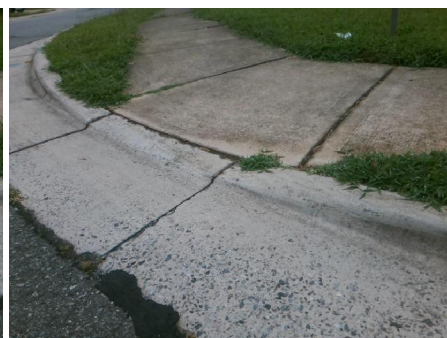
Intersection ID: 29267	Main Street: LAKOTA_CT	Cross Street: HORACE_MANN_RD	Location: S
ADA ID: B4A2F46E708E	Ramp Type: PerpDiag	Initial Pass/Fail: Fail	Overall Compliance: No
Severity Score: 8.75			
Codes/Mitigation Info/Possible Solution		Field Measurements/Component Compliance

PROW/ADA:

Not Found, R304.5.1

Compliance	Description	Data	Compliance	Description	Data
N/A	Ramp Length (in)	72.0	Yes	Ramp Slope (%)	5.8
No	Ramp Width (in)	37.0	Yes	Ramp XSlope (%)	1.8
N/A	Flare Type LT	N/A	N/A	Flare Type RT	N/A
N/A	Flare Slope LT (%)	N/A	N/A	Flare Slope RT (%)	N/A
N/A	Flare Traversable LT?	N/A	N/A	Flare Traversable RT?	N/A
N/A	Landing Length (in)	N/A	N/A	DWS Provided?	N/A
N/A	Landing Width (in)	N/A	N/A	DWS Contrast?	N/A
N/A	Landing Slope (%)	N/A	N/A	DWS Length (in)	N/A
N/A	Landing X Slope (%)	N/A	N/A	DWS Full Width?	N/A
N/A	Landing Curb? (Y/N)	N/A	N/A	DWS Offset (in)	N/A
N/A	Shared Landing?	N/A			
N/A	Gutter Ponding?	N/A	N/A	Gutter Slope (%)	N/A
N/A	Gutter Lip Ht (in)	0.5	N/A	Gutter X Slope (%)	N/A
N/A	Painted X Walk1?	No	N/A	Painted X Walk2?	No
	X Walk 1 Direction	To E		X Walk 2 Direction	To W
N/A	X Walk 1 Width (in)	N/A	N/A	X Walk 2 Width (in)	N/A
	X Walk 1 Slope (%)	2.1		X Walk 2 Slope (%)	1.8
	X Walk 1 X Slope (%)	1.7		X Walk 2 X Slope (%)	4.1

N/A	Ramp inside XWalk1?	N/A	N/A	Ramp inside XWalk2?	N/A
	Road Slope (%)	2.0	N/A	Clear Space?	N/A
	Road X Slope (%)	1.8	N/A	Clear Space to XWalk (in)	N/A
N/A	Any Obstructions?	N/A	N/A	Storm Grate/Utility Hazard?	N/A
	Obstruction Type			Storm Grate/Utility Type	
		N/A			N/A
			Yes	Surface Condition? (G/P)	Good

Possible Solutions:

Remove & Replace Curb Ramp With Two New Directional Ramps or Equivalent.
