# Access Compliance Report

## Public Rights-of-Way

### (Curb Ramps)

| Intersection ID: 27452 | Main Street: BALLANTYNE COMMONS PY | Cross Street: BALLANTYNE CORPORATE PL | Location: SW |

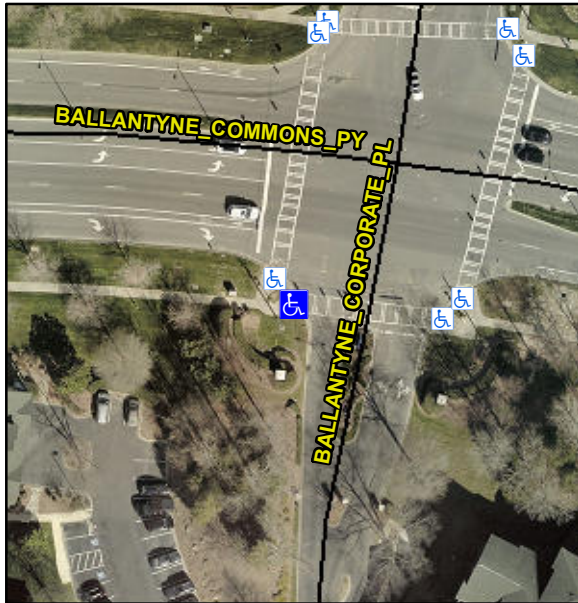
**Not Found, R304.5.3, R305.1.4, R305.2, R302.7.2**

**Remove & Replace Curb Ramp With Two New Directional Ramps or Equivalent.**

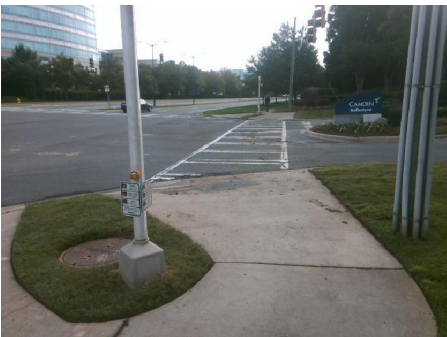
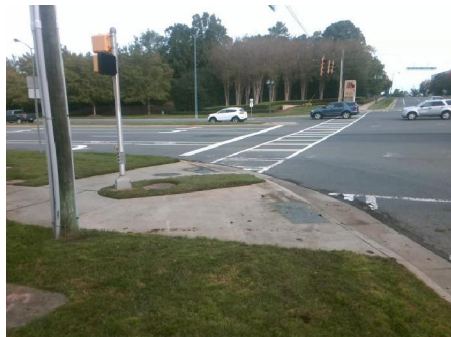
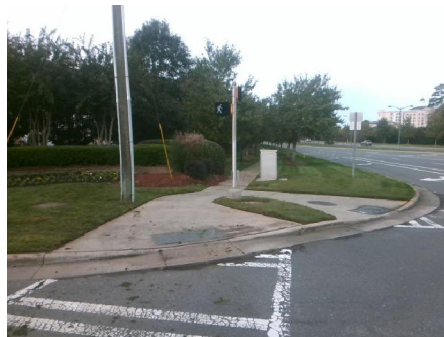
| Compliance | Description | Data | Compliance | Description | Data |
|---|---|---|---|---|---|
| Yes | Ramp Width (in) | 48.0 | No | BlendTrans XSlope (%) | 2.5 |
| Yes | Landing X Slope (%) | 0.2 | No | DWS Full Width? | No |
| N/A | Landing Curb? (Y/N) | No | No | DWS Offset (in) | 5.0 |
| No | Gutter Lip Ht (in) | 2.5 | Yes | Gutter X Slope (%) | 0.4 |
| | | | No | Curb Slope (%) | 11.1 |
