Access Compliance Report Public Rights-of-Way (Curb Ramps)

Intersection ID: 31609 Main Street: WINDY_VALLEY_DR Cross Street: PALM_BREEZE_LN Location: SE

ADA ID: B4ABE53A3DA8 Ramp Type: PerpDiag Initial Pass/Fail: Pass Overall Compliance: No Severity Score: 10

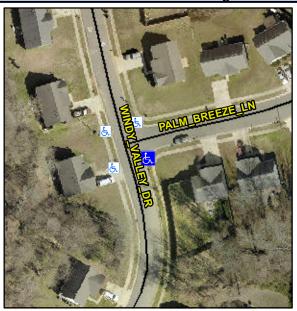
Not Found, R304.2.2-Perp, R304.3.2-Para, R304.5.3, R305.1.4, R305.2, R302.7.2

ricia measurements/osmponent compinance					
Compliance Description		Data	Compliance Description		Data
N/A	Ramp Length (in)	51.0	Yes	Ramp Slope (%)	6.1
Yes	Ramp Width (in)	52.0	Yes	Ramp XSlope (%)	1.5
N/A	Flare Type LT	Sloped	N/A	Flare Type RT	N/A
N/A	Flare Slope LT (%)	6.1	Yes	Flare Slope RT (%)	3.7
N/A	Flare Traversable LT?	Yes	N/A	Flare Traversable RT?	Yes
Yes	Landing Length (in)	48.0	Yes	DWS Provided?	Yes
Yes	Landing Width (in)	52.0	Yes	DWS Contrast?	Yes
No	Landing Slope (%)	3.3	Yes	DWS Length (in)	24.0
No	Landing X Slope (%)	3.0	No	DWS Full Width?	No
N/A	Landing Curb? (Y/N)	No	No	DWS Offset (in)	3.0
N/A	Shared Landing?	No			
Yes	Gutter Ponding?	No	Yes	Gutter Slope (%)	1.6
No	Gutter Lip Ht (in)	0.5	Yes	Gutter X Slope (%)	1.1
N/A	Painted X Walk1?	No	N/A	Painted X Walk2?	No
	X Walk 1 Direction	To N		X Walk 2 Direction	To W
N/A	X Walk 1 Width (in)	N/A	N/A	X Walk 2 Width (in)	N/A
	X Walk 1 Slope (%)	5.1		X Walk 2 Slope (%)	7.1

X Walk 1 X Slope (%)	0.3		X Walk 2 X Slope (%)	1.6
N/A	Ramp inside XWalk1?	N/A	N/A	Ramp inside XWalk2?	N/A
	Road Slope (%)	0.4	N/A	Clear Space?	Yes
	Road X Slope (%)	3.4	N/A	Clear Space to XWalk (in)	N/A
Yes	Any Obstructions?	No	Yes	Storm Grate/Utility Hazard?	No
	Obstruction Type		l	Storm Grate/Utility Type

PALM BREEZE LN StopSign WINDY VALLEY DR None Possible Solutions:

Remove & Replace Curb Ramp With Two New Directional Ramps or Equivalent.
