Access Compliance Report

Public Rights-of-Way

(Curb Ramps)

Intersection ID: 10637	Main Street: COKER_AV	Cross Street: MATHIS_DR	Location: E
ADA ID: B4AC8E7F32C3	Ramp Type: Directional1	Initial Pass/Fail: Fail	Overall Compliance: No
		Severity Score: 12.5

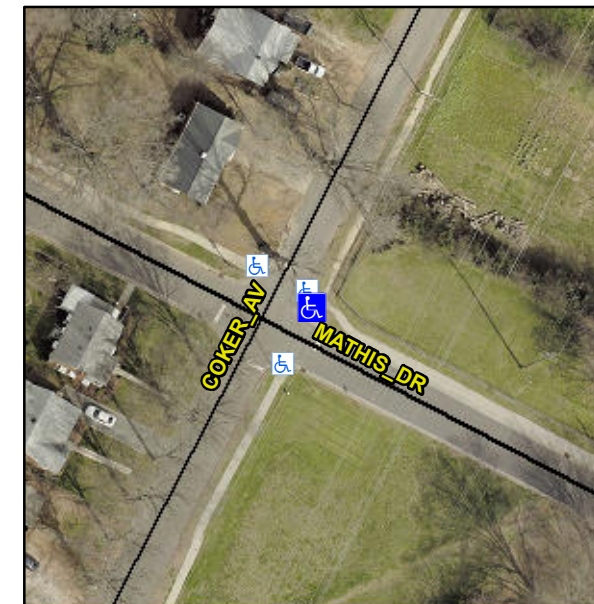
R304.2.2

Compliance	Description	Data	Compliance	Description	Data
N/A	Ramp Length (in)	52.0	N/A	Grade Break?	N/A
Yes	Ramp Width (in)	57.0	N/A	Grade Break Slope (%)	0.0
No	Ramp Slope (%)	8.5	N/A	Grade Break XSlope (%)	0.0
Yes	Ramp XSlope (%)	0.5			
N/A	Flare Type LT	N/A	N/A	Flare Type RT	N/A
N/A	Flare Slope LT (%)	N/A	N/A	Flare Slope RT (%)	0.0
N/A	Flare Traversable LT?	N/A	N/A	Flare Traversable RT?	N/A
N/A	Landing Length (in)	0.0	N/A	DWS Provided?	N/A
N/A	Landing Width (in)	0.0	N/A	DWS Contrast?	N/A
N/A	Landing Slope (%)	0.0	N/A	DWS Length (in)	N/A
N/A	Landing X Slope (%)	0.0	N/A	DWS Full Width?	N/A
N/A	Landing Curb? (Y/N)	N/A	N/A	DWS Offset LT (in)	N/A
N/A	Shared Landing?	N/A	N/A	DWS Offset RT (in)	N/A
N/A	Gutter Ponding?	Yes	N/A	Gutter Slope (%)	N/A
N/A	Gutter Lip Ht (in)	0.0	N/A	Gutter X Slope (%)	N/A
N/A	Painted X Walk1?	No		Road Slope (%)	0.1
	X Walk 1 Direction	To SW		Road X Slope (%)	0.6
	X Walk 1 Width (in)	N/A		Clear Space?	N/A

X Walk 1 Slope (%)	0.1	N/A	Clear Space to XWalk (in)	N/A
	X Walk 1 X Slope (%)	0.6	N/A	Storm Grate/Utility Hazard?	N/A
N/A	Ramp inside XWalk1?	N/A		Storm Grate/Utility Type	
N/A	Any Obstructions?	N/A			N/A
	Obstruction Type		Yes	Surface Condition? (G/P)	Good
			N/A	Curb Slope (%)	10.4

Remove & Replace Entire Ramp.

Total Cost: \$ 1600.00
