# Access Compliance Report

## Public Rights-of-Way

### (Curb Ramps)

| Intersection ID: 5421 | Main Street: SUNSET_RD | Cross Street: OLD_STATESVILLE_RD | Location: W |

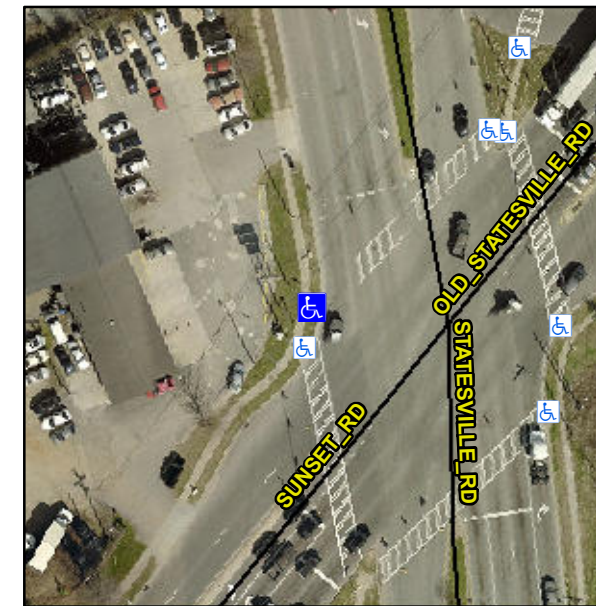
| ADA ID: B4B1EFE638B1 | Ramp Type: Perp | Initial Pass/Fail: Fail | Overall Compliance: No |
| Severity Score: 21.25 | | | |

**Not Found, R304.5.1, R304.2.2**

| Compliance | Description | Data | Compliance | Description | Data |
|---|---|---|---|---|---|
| N/A | Ramp Length (in) | 63.0 | No | Ramp Slope (%) | 9.1 |
| No | Ramp Width (in) | 47.0 | Yes | Ramp XSlope (%) | 0.0 |

**Remove & Replace Entire Ramp.**

Total Cost: \$ 1850.00
