Access Compliance Report Public Rights-of-Way (Curb Ramps)

Intersection ID: 30141 Main Street: FABYAN_LN Cross Street: RUMPLE_RD Location: SE

ADA ID: B4C2427C4802 Ramp Type: Perp Initial Pass/Fail: Fail Overall Compliance: No Severity Score: 8.75

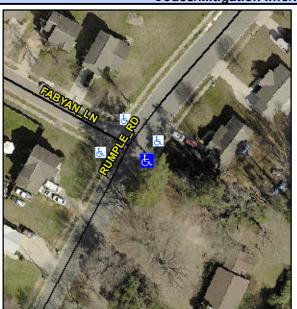
Field Measurements/Component Compliance						
Compliance Description		Data	Compliance Description		Data	
N/A	Ramp Length (in)	48.0	Yes	Ramp Slope (%)	6.8	
No	Ramp Width (in)	42.0	Yes	Ramp XSlope (%)	0.3	
N/A	Flare Type LT	N/A	N/A	Flare Type RT	N/A	
N/A	Flare Slope LT (%)	N/A	N/A	Flare Slope RT (%)	N/A	
N/A	Flare Traversable LT?	N/A	N/A	Flare Traversable RT?	N/A	
N/A	Landing Length (in)	N/A	N/A	DWS Provided?	N/A	
N/A	Landing Width (in)	N/A	N/A	DWS Contrast?	N/A	
N/A	Landing Slope (%)	N/A	N/A	DWS Length (in)	N/A	
N/A	Landing X Slope (%)	N/A	N/A	DWS Full Width?	N/A	
N/A	Landing Curb? (Y/N)	N/A	N/A	DWS Offset (in)	N/A	
N/A	Shared Landing?	N/A				
N/A	Gutter Ponding?	N/A	N/A	Gutter Slope (%)	N/A	
N/A	Gutter Lip Ht (in)	0.5	N/A	Gutter X Slope (%)	N/A	
N/A	Painted X Walk1?	No	N/A	Painted X Walk2?	N/A	
	X Walk 1 Direction	To NW		X Walk 2 Direction	N/A	
N/A	X Walk 1 Width (in)	N/A	N/A	X Walk 2 Width (in)	N/A	
	X Walk 1 Slope (%)	3.0		X Walk 2 Slope (%)	N/A

X Walk 1 X Slope (%)	2.7		X Walk 2 X Slope (%)	N/A	
N/A	Ramp inside XWalk1?	N/A	N/A	Ramp inside XWalk2?	N/A	
	Road Slope (%)	N/A	N/A	Clear Space?	N/A	
	Road X Slope (%)	N/A	N/A	Clear Space to XWalk (in)	N/A	
N/A	Any Obstructions?	N/A	N/A	Storm Grate/Utility Hazard?	N/A	
	Obstruction Type			Storm Grate/Utility Type		
		N/A			N/A	
			Yes	Surface Condition? (G/P)	Good

Possible Solutions:	C		
Remove & Replace Entire Ramp.			
•	No		
	N/		
Surveyor Notes:	N/		
N/A	N/		
	N/		
	N/		
	N/		
PROW/ADA:	N/		
Not Found, R304.5.1	N/		
	N/		
	N/

Total Cost: \$ 1850.00
