Access Compliance Report

Public Rights-of-Way

(Curb Ramps)

Intersection ID: 53776	Main Street: ELEANOR_RIGBY_RD	Cross Street: CHAPECLANE_RD	Location: NE
ADA ID: B4C57077BF3D	Ramp Type: Perp	Initial Pass/Fail: Fail	Overall Compliance: No
		Severity Score: 10

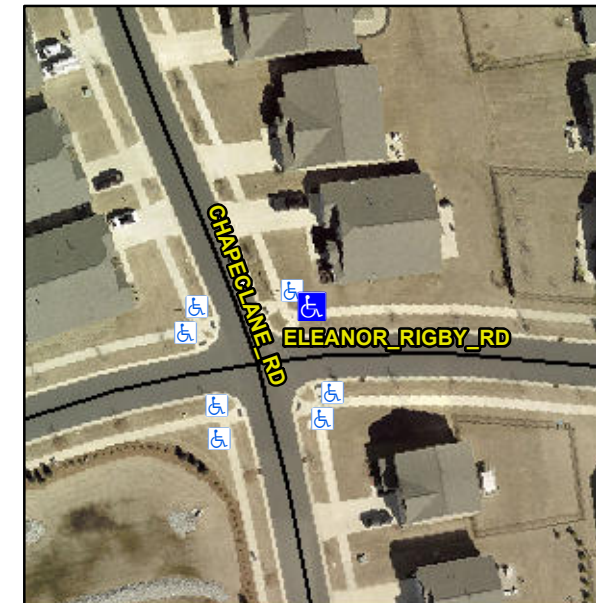
Not Found, R304.5.1, R304.5.3

Compliance	Description	Data	Compliance	Description	Data
N/A	Ramp Length (in)	93.0	Yes	Ramp Slope (%)	7.8
No	Ramp Width (in)	42.0	No	Ramp XSlope (%)	2.8
N/A	Flare Type LT	N/A	N/A	Flare Type RT	N/A
N/A	Flare Slope LT (%)	N/A	N/A	Flare Slope RT (%)	N/A
N/A	Flare Traversable LT?	N/A	N/A	Flare Traversable RT?	N/A
N/A	Landing Length (in)	N/A	N/A	DWS Provided?	N/A
N/A	Landing Width (in)	N/A	N/A	DWS Contrast?	N/A
N/A	Landing Slope (%)	N/A	N/A	DWS Length (in)	N/A
N/A	Landing X Slope (%)	N/A	N/A	DWS Full Width?	N/A
N/A	Landing Curb? (Y/N)	N/A	N/A	DWS Offset (in)	N/A
N/A	Shared Landing?	N/A			
N/A	Gutter Ponding?	N/A	N/A	Gutter Slope (%)	N/A
N/A	Gutter Lip Ht (in)	N/A	N/A	Gutter X Slope (%)	N/A
N/A	Painted X Walk1?	No	N/A	Painted X Walk2?	N/A
	X Walk 1 Direction	To S		X Walk 2 Direction	N/A
N/A	X Walk 1 Width (in)	N/A	N/A	X Walk 2 Width (in)	N/A
	X Walk 1 Slope (%)	0.5		X Walk 2 Slope (%)	N/A
	X Walk 1 X Slope (%)	1.3		X Walk 2 X Slope (%)	N/A

Remove & Replace Entire Ramp.
