Access Compliance Report Public Rights-of-Way (Curb Ramps)

Interpostion ID: 29450	Main St			Croco	Streat				Loostion	NW	
Intersection ID: 28450	wain Str	Main Street: ANDREW_JAMES_DR			Cross Street: SIERRA_WOODS_CT				Location:		
ADA ID: B4D46029EB5E	Ramp Ty	Ramp Type: Perp			Initial Pass/Fail: Fail Overall Compliance: No				Severity Score:	33.75	
Codes/Mitigation Info/Possible Solution					Field Measurements/Component Compliance						
		Possible Solutions:		Compliance Description			Data	Data Compliance Description		Data	
		Remove & Re	eplace Entire Ram	0.	N/A	Ramp Length (in)	98.0	Yes	Ramp Slope (%)	7.8	
	100				No	Ramp Width (in)	46.0	No	Ramp XSlope (%)	8.4

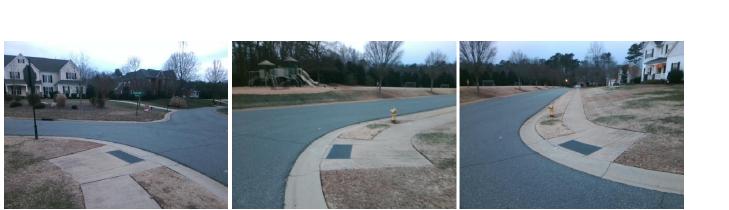
B. Com				N/A	Flare Type LT	N/A	N/A	Flare Type RT	N/A	
					N/A	Flare Slope LT (%)	N/A	N/A	Flare Slope RT (%)	N/A	
					N/A	Flare Traversable LT?	N/A	N/A	Flare Traversable RT?	N/A	
	11 1				N/A	Landing Length (in)	N/A	N/A	DWS Provided?	N/A	
ANDREW JAMES		Surveyor Notes:			N/A	Landing Width (in)	N/A	N/A	DWS Contrast?	N/A	
	in the	N/A			N/A	Landing Slope (%)	N/A	N/A	DWS Length (in)	N/A	
Tors of	C ARE FOR				N/A	Landing X Slope (%)	N/A	N/A	DWS Full Width?	N/A	
AND THE MANDER	1814				N/A	Landing Curb? (Y/N)	N/A	N/A	DWS Offset (in)	N/A	
A A A A A A A A A A A A A A A A A A A	Alt				N/A	Shared Landing?	N/A				
Cart Carthe	and the co	PROW/ADA:			N/A	Gutter Ponding?	N/A	N/A	Gutter Slope (%)	N/A	
A Company of the	ALL CAL	Not Found, I	R304.5.1, R304.5.3		N/A	Gutter Lip Ht (in)	N/A	N/A	Gutter X Slope (%)	N/A	
A CALINARY SAL	11	,	,		N/A	Painted X Walk1?	No	N/A	Painted X Walk2?	N/A	
and the second second	1					X Walk 1 Direction	To E		X Walk 2 Direction	N/A

and the second				N/A	X Walk 1 Width (in)	N/A	N/A	X Walk 2 Width (in)	N/A		
Street 1 Name	SIERRA WOODS CT					X Walk 1 Slope (%)	2.7		X Walk 2 Slope (%)	N/A	
Stop Condition-Street 2	StopSign					X Walk 1 X Slope (%)	2.0		X Walk 2 X Slope (%)	N/A	
Street 2 Name	N/A				N/A	Ramp inside XWalk1?	N/A	N/A	Ramp inside XWalk2?	N/A	
Stop Condition-Street 1	N/A					Road Slope (%)	2.0	N/A	Clear Space?	N/A	
						Road X Slope (%)	2.7	N/A	Clear Space to XWalk (in)	N/A	
					N/A	Any Obstructions?	N/A	N/A	Storm Grate/Utility Hazard?	N/A	
		Total Cost:	\$	1850.00		Obstruction Type			Storm Grate/Utility Type		
							N/A			N/A

Yes Surface Condition? (G/P)

Good
