Access Compliance Report

Public Rights-of-Way

(Curb Ramps)

Intersection ID: 24700	Main Street: HARLEQUIN_DR	Cross Street: WHISTLING_DUCK_CT	Location: SW
ADA ID: B4D9721F9ECC	Ramp Type: Directional1	Initial Pass/Fail: Fail	Overall Compliance: No
		Severity Score: 21.25

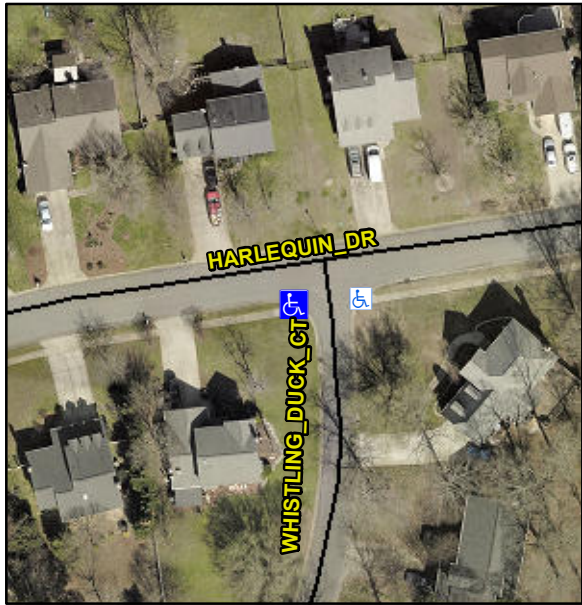
Possible Solutions:		Compliance	Description	Data	Compliance	Description	Data
	Remove & Replace Entire Ramp.		N/A	Ramp Length (in)	62.0	N/A	Grade Break?	N/A
			No	Ramp Width (in)	43.0	N/A	Grade Break Slope (%)	0.0
			Yes	Ramp Slope (%)	5.0	N/A	Grade Break XSlope (%)	0.0
			No	Ramp XSlope (%)	5.8			
			N/A	Flare Type LT	N/A	N/A	Flare Type RT	N/A
			N/A	Flare Slope LT (%)	N/A	N/A	Flare Slope RT (%)	0.0
			N/A	Flare Traversable LT?	N/A	N/A	Flare Traversable RT?	N/A
			N/A	Landing Length (in)	0.0	N/A	DWS Provided?	N/A
			N/A	Landing Width (in)	0.0	N/A	DWS Contrast?	N/A
Surveyor Notes:		N/A	N/A	Landing Slope (%)	0.0	N/A	DWS Length (in)	N/A
		N/A	N/A	Landing X Slope (%)	0.0	N/A	DWS Full Width?	N/A
PROW/ADA:		R304.5.1, R304.5.3	N/A	Landing Curb? (Y/N)	N/A	N/A	DWS Offset LT (in)	N/A
			N/A	Shared Landing?	N/A	N/A	DWS Offset RT (in)	N/A

N/A	Gutter Ponding?	0.0	N/A	Gutter Slope (%)	N/A
			N/A	Gutter Lip Ht (in)	0.0	N/A	Gutter X Slope (%)	N/A
			N/A	Painted X Walk1?	No		Road Slope (%)	1.0
				X Walk 1 Direction	To NE		Road X Slope (%)	2.8
				X Walk 1 Width (in)	N/A		Clear Space?	N/A
				X Walk 1 Slope (%)	1.0	N/A	Clear Space to XWalk (in)	N/A
				X Walk 1 X Slope (%)	2.8	N/A	Storm Grate/Utility Hazard?	N/A
			N/A	Ramp inside XWalk1?	N/A		Storm Grate/Utility Type	
			N/A	Any Obstructions?	N/A			N/A
				Obstruction Type		Yes	Surface Condition? (G/P)	Good
						N/A	Curb Slope (%)	16.8
Total Cost:		\$ 1600.00
