Access Compliance Report

Public Rights-of-Way

(Curb Ramps)

Intersection ID: 3373	Main Street: KATELYN_DR	Cross Street: PROSPERITY_CHURCH_RD	Location: W
ADA ID: B4DCB5648DA7	Ramp Type: Para	Initial Pass/Fail: Pass	Overall Compliance: No
			Severity Score: 10.25

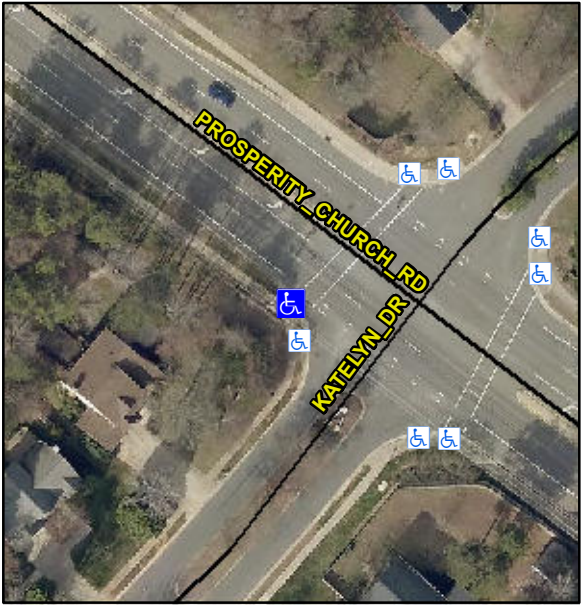
Compliance	Description	Data	Compliance	Description	Data
N/A	Ramp Length LT (in)	51.5	N/A	Ramp Length RT (in)	57.5
Yes	Ramp Width LT (in)	59.0	Yes	Ramp Width RT (in)	57.5
Yes	Ramp Slope LT (%)	5.8	Yes	Ramp Slope RT (%)	5.5
Yes	Ramp XSlope LT (%)	1.7	No	Ramp XSlope RT (%)	2.1
Yes	Landing Length (in)	107.5	No	DWS Provided?	No
No	Landing Width (in)	33.0	N/A	DWS Contrast?	No
No	Landing Slope (%)	5.2	N/A	DWS Length (in)	N/A
No	Landing X Slope (%)	2.2	N/A	DWS Full Width?	No
N/A	Landing Curb? (Y/N)	No	N/A	DWS Offset (in)	N/A
N/A	Shared Landing?	No			
Yes	Gutter Ponding?	No	Yes	Gutter Slope (%)	1.9
Yes	Gutter Lip Ht (in)	0.0	No	Gutter X Slope (%)	2.5
N/A	Painted X Walk1?	Yes	N/A	Painted X Walk2?	N/A
	X Walk 1 Direction	To NE		X Walk 2 Direction	N/A
N/A	X Walk 1 Width (in)	113.0	N/A	X Walk 2 Width (in)	N/A
	X Walk 1 Slope (%)	2.2		X Walk 2 Slope (%)	N/A
	X Walk 1 X Slope (%)	1.6		X Walk 2 X Slope (%)	N/A
Yes	Ramp inside XWalk1?	Yes	N/A	Ramp inside XWalk2?	N/A

Road Slope (%)	N/A	N/A	Clear Space?	Yes
	Road X Slope (%)	N/A	N/A	Clear Space to XWalk (in)	N/A
Yes	Any Obstructions?	No	Yes	Storm Grate/Utility Hazard?	No
	Obstruction Type			Storm Grate/Utility Type	
		N/A			N/A
			Yes	Surface Condition? (G/P)	Good
			N/A	Curb Slope (%)	12.3

Possible Solutions:				
	Remove & Replace Entire Ramp.				
	Remove & Replace Gutter.				
	Surveyor Notes:				
	N/A				
	PROW/ADA:				
	R304.5.3, R304.2.1, R304.2.2-Perp,				
	R304.3.2-Para, R305				
Street 1 Name	PROSPERITY CHURCH RD				
Stop Condition-Street 1	None				
Street 2 Name	N/A				
Stop Condition-Street 2	N/A				
Total Cost:		\$	2350.00
