# Access Compliance Report

## Public Rights-of-Way

### (Curb Ramps)

| Intersection ID: 9278 | Main Street: OAKLAWN_AV | Cross Street: BOOKER_AV | Location: SE |

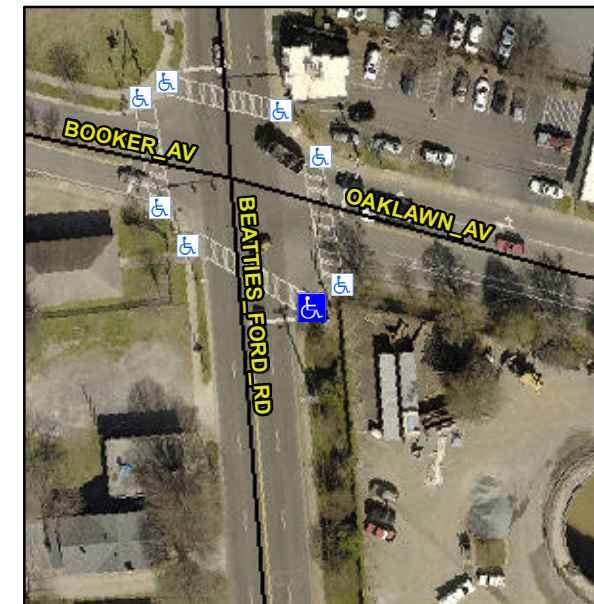
| ADA ID: B4E2FBBA1702 | Ramp Type: Perp | Initial Pass/Fail: Fail | Overall Compliance: No |
| | | Severity Score: 22.5 | |

**Not Found, R304.5.1, R304.2.2**

| Compliance | Description | Data | Compliance | Description | Data |
|---|---|---|---|---|---|
| N/A | Ramp Length (in) | 61.0 | No | Ramp Slope (%) | 10.3 |
| No | Ramp Width (in) | 39.0 | Yes | Ramp XSlope (%) | 4.1 |

**Remove & Replace Entire Ramp.**

Total Cost: \$ 1850.00
