## Access Compliance Report Public Rights-of-Way (Curb Ramps)

Intersection ID: 48018 Main Street: ROYAL\_CASTLE\_CT Cross Street: TULLY\_HOUSE\_CT Location: S

ADA ID: B4E484870716 Ramp Type: Perp Initial Pass/Fail: Pass Overall Compliance: No Severity Score: 10.25

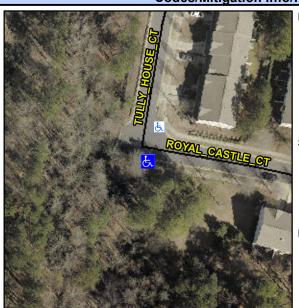
Field Measurements/Component Compliance					
Compli	ance Description	Data	Comp	liance Description	Data
N/A	Ramp Length (in)	48.0	Yes	Ramp Slope (%)	6.5
Yes	Ramp Width (in)	48.0	No	Ramp XSlope (%)	4.3
N/A	Flare Type LT	Sloped	N/A	Flare Type RT	N/A
N/A	Flare Slope LT (%)	6.5	Yes	Flare Slope RT (%)	0.2
N/A	Flare Traversable LT?	Yes	N/A	Flare Traversable RT?	Yes
Yes	Landing Length (in)	48.5	No	DWS Provided?	No
Yes	Landing Width (in)	49.5	N/A	DWS Contrast?	No
No	Landing Slope (%)	2.5	N/A	DWS Length (in)	N/A
Yes	Landing X Slope (%)	2.2	N/A	DWS Full Width?	No
N/A	Landing Curb? (Y/N)	No	N/A	DWS Offset (in)	N/A
N/A	Shared Landing?	No			
Yes	Gutter Ponding?	No	Yes	Gutter Slope (%)	1.7
Yes	Gutter Lip Ht (in)	0.0	Yes	Gutter X Slope (%)	1.7
N/A	Painted X Walk1?	No	N/A	Painted X Walk2?	N/A
	X Walk 1 Direction	To NE		X Walk 2 Direction	N/A
N/A	X Walk 1 Width (in)	N/A	N/A	X Walk 2 Width (in)	N/A
	X Walk 1 Slope (%)	1.4		X Walk 2 Slope (%)	N/A

X Walk 1 X Slope (%)	2.8		X Walk 2 X Slope (%)	N/A
N/A	Ramp inside XWalk1?	N/A	N/A	Ramp inside XWalk2?	N/A
	Road Slope (%)	N/A	N/A	Clear Space?	Yes
	Road X Slope (%)	N/A	N/A	Clear Space to XWalk (in)	N/A
Yes	Any Obstructions?	No	Yes	Storm Grate/Utility Hazard?	No
	Obstruction Type		l	Storm Grate/Utility Type	
		N/A			N/A
			Yes	Surface Condition? (G/P)	Good
	1 1 1 1 1 1 1 1 1 1 1 1 1 1 1 1 1 1 1

Remove & Replace Entire Ramp.

Not Found, R304.5.3, R304.2.2-Perp,
R304.3.2-Para, R305

Total Cost:	\$ 1850.00
