Access Compliance Report Public Rights-of-Way (Curb Ramps)

Intersection ID: 1001312 Main Street: FOGGY_MEADOW_RD Cross Street: N/A Location: E

ADA ID: B4E76FA8A471 Ramp Type: Para Initial Pass/Fail: Pass Overall Compliance: No Severity Score: 0.25

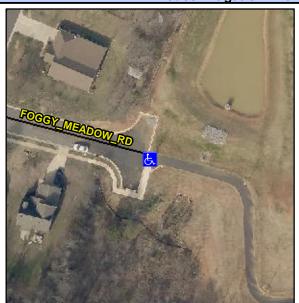
Compliance Description Data Compliance Description Data N/A N/A N/A Ramp Length LT (in) Ramp Length RT (in) 71.0 N/A N/A Ramp Width LT (in) Yes Ramp Width RT (in) 71.0 N/A Ramp Slope LT (%) N/A Yes Ramp Slope RT (%) 6.3 N/A Ramp XSlope LT (%) N/A No Ramp XSlope RT (%) 2.9 Yes Landing Length (in) 71.0 Yes DWS Provided? Yes Yes Landing Width (in) 118.5 Yes **DWS Contrast?** Yes Yes Landing Slope (%) 1.5 Yes DWS Length (in) 24.0 Landing X Slope (%) 2.2 Yes DWS Full Width? No Yes N/A Landing Curb? (Y/N) No Yes DWS Offset (in) 2.0 N/A Shared Landing? No Yes Yes Gutter Ponding? No Gutter Slope (%) 4.6 Yes Gutter Lip Ht (in) 0.0 Yes Gutter X Slope (%) 1.2 N/A Painted X Walk1? No N/A Painted X Walk2? N/A X Walk 1 Direction To W X Walk 2 Direction N/A N/A X Walk 1 Width (in) N/A N/A X Walk 2 Width (in) N/A X Walk 1 Slope (%) X Walk 2 Slope (%) 0.4 N/A X Walk 1 X Slope (%) 1.7 X Walk 2 X Slope (%) N/A Ramp inside XWalk2? N/A Ramp inside XWalk1? N/A N/A N/A N/A N/A Road Slope (%) Clear Space? Yes Road X Slope (%) N/A N/A Clear Space to XWalk (in) N/A Any Obstructions? No Yes Storm Grate/Utility Hazard? Yes No **Obstruction Type** Storm Grate/Utility Type N/A N/A Surface Condition? (G/P) Yes Good

Possible Solutions:

Remove & Replace Entire Ramp.

R304.5.3
