Access Compliance Report Public Rights-of-Way (Curb Ramps)

Intersection ID: 47400 Main Street: OVERLAND_PARK_LN Cross Street: FLAT_RIVER_DR Location: W

ADA ID: B4EBECBD3A41 Ramp Type: Perp Initial Pass/Fail: Fail Overall Compliance: No Severity Score: 13.75

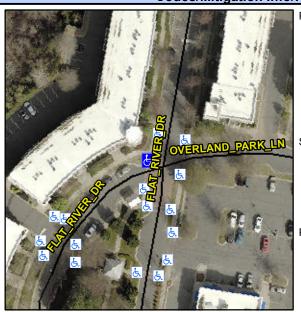
Field Measurements/Component Compliance						
Comp	liance Description	Data	Comp	liance	Description	Data
N/A	Ramp Length (in)	56.0	No	Ramp	Slope (%)	9.7
Yes	Ramp Width (in)	53.5	No	Ramp	XSlope (%)	3.1
N/A	Flare Type LT	N/A	N/A	Flare	Type RT	N/A
N/A	Flare Slope LT (%)	N/A	N/A	Flare	Slope RT (%)	N/A
N/A	Flare Traversable LT?	N/A	N/A	Flare	Traversable RT?	N/A
N/A	Landing Length (in)	N/A	N/A	DWS	Provided?	N/A
N/A	Landing Width (in)	N/A	N/A	DWS	Contrast?	N/A
N/A	Landing Slope (%)	N/A	N/A	DWS	Length (in)	N/A
N/A	Landing X Slope (%)	N/A	N/A	DWS	Full Width?	N/A
N/A	Landing Curb? (Y/N)	N/A	N/A	DWS	Offset (in)	N/A
N/A	Shared Landing?	N/A				
N/A	Gutter Ponding?	N/A	N/A	Gutte	r Slope (%)	N/A
N/A	Gutter Lip Ht (in)	N/A	N/A	Gutte	r X Slope (%)	N/A
N/A	Painted X Walk1?	Yes	N/A	Paint	ed X Walk2?	N/A
	X Walk 1 Direction	To SW		X Wa	lk 2 Direction	N/A
N/A	X Walk 1 Width (in)	51.0	N/A	X Wa	lk 2 Width (in)	N/A
	X Walk 1 Slope (%)	1.6		X Wa	lk 2 Slope (%)	N/A

X Walk 1 X Slope (%)	2.5		X Wa	lk 2 X Slope (%)	N/A
N/A	Ramp inside XWalk1?	Yes	N/A	Ramp	inside XWalk2?	N/A
	Road Slope (%)	N/A	N/A	Clear	Space?	N/A
	Road X Slope (%)	N/A	N/A	Clear	Space to XWalk (in)	N/A
N/A	Any Obstructions?	N/A	N/A	Storm	Grate/Utility Hazard?	N/A
	Obstruction Type			Storm	Grate/Utility Type	
		N/A				N/A
			Yes	Surfa	ce Condition? (G/P)	Good

Possible Solutions:	C
Remove & Replace Entire Ramp.	
·	Ye
	N/
	N
	N
	N
Surveyor Notes:	N
N/A	N
	N
	N
	N
PROW/ADA:	N
R304.2.2, R304.5.3	N/
	N
	N
	N
