Access Compliance Report

Public Rights-of-Way

(Curb Ramps)

Intersection ID: N/A	Main Street: INDEPENDENCE_RD	Cross Street: N/A	Location: SE
ADA ID: B4EE427332CF	Ramp Type: PerpDiag	Initial Pass/Fail: Fail	Overall Compliance: No
Severity Score: 12.5			
Codes/Mitigation Info/Possible Solution		Field Measurements/Component Compliance

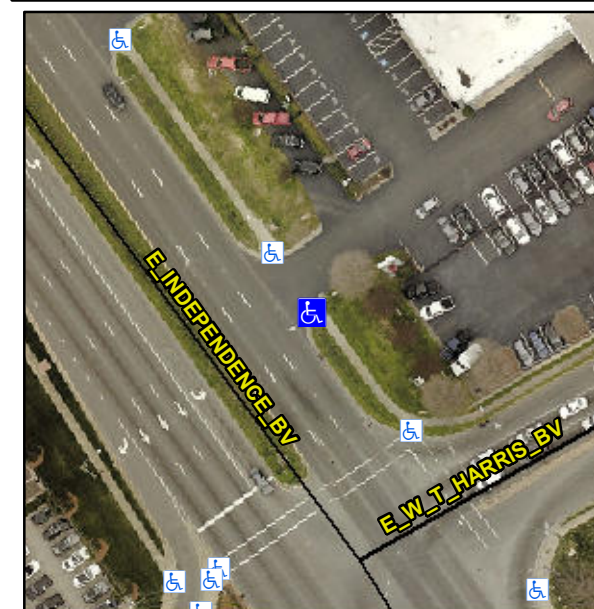
Not Found, R304.5.3

Compliance	Description	Data	Compliance	Description	Data
N/A	Ramp Length (in)	62.0	Yes	Ramp Slope (%)	7.8
Yes	Ramp Width (in)	54.0	No	Ramp XSlope (%)	5.2
N/A	Flare Type LT	N/A	N/A	Flare Type RT	N/A
N/A	Flare Slope LT (%)	N/A	N/A	Flare Slope RT (%)	N/A
N/A	Flare Traversable LT?	N/A	N/A	Flare Traversable RT?	N/A
N/A	Landing Length (in)	N/A	N/A	DWS Provided?	N/A
N/A	Landing Width (in)	N/A	N/A	DWS Contrast?	N/A
N/A	Landing Slope (%)	N/A	N/A	DWS Length (in)	N/A
N/A	Landing X Slope (%)	N/A	N/A	DWS Full Width?	N/A
N/A	Landing Curb? (Y/N)	N/A	N/A	DWS Offset (in)	N/A
N/A	Shared Landing?	N/A			
N/A	Gutter Ponding?	N/A	N/A	Gutter Slope (%)	N/A
N/A	Gutter Lip Ht (in)	N/A	N/A	Gutter X Slope (%)	N/A
N/A	Painted X Walk1?	No	N/A	Painted X Walk2?	No
	X Walk 1 Direction	To NW		X Walk 2 Direction	To W
N/A	X Walk 1 Width (in)	N/A	N/A	X Walk 2 Width (in)	N/A
	X Walk 1 Slope (%)	4.8		X Walk 2 Slope (%)	2.8
	X Walk 1 X Slope (%)	2.2		X Walk 2 X Slope (%)	2.9

N/A	Ramp inside XWalk1?	N/A	N/A	Ramp inside XWalk2?	N/A
	Road Slope (%)	5.2	N/A	Clear Space?	N/A
	Road X Slope (%)	0.9	N/A	Clear Space to XWalk (in)	N/A
N/A	Any Obstructions?	N/A	N/A	Storm Grate/Utility Hazard?	N/A
	Obstruction Type			Storm Grate/Utility Type	
		N/A			N/A
		Yes		Surface Condition? (G/P)	Good

Remove & Replace Curb Ramp With Two New Directional Ramps or Equivalent.

Total Cost: \$ 3200.00
