Access Compliance Report

Public Rights-of-Way

(Curb Ramps)

Intersection ID: 11148	Main Street: MATHESON_AV	Cross Street: VIRGINIA_AV	Location: E
ADA ID: B4F20DB7F71D	Ramp Type: PerpDiag	Initial Pass/Fail: Fail	Overall Compliance: No
Severity Score: 8.75			
Codes/Mitigation Info/Possible Solution		Field Measurements/Component Compliance

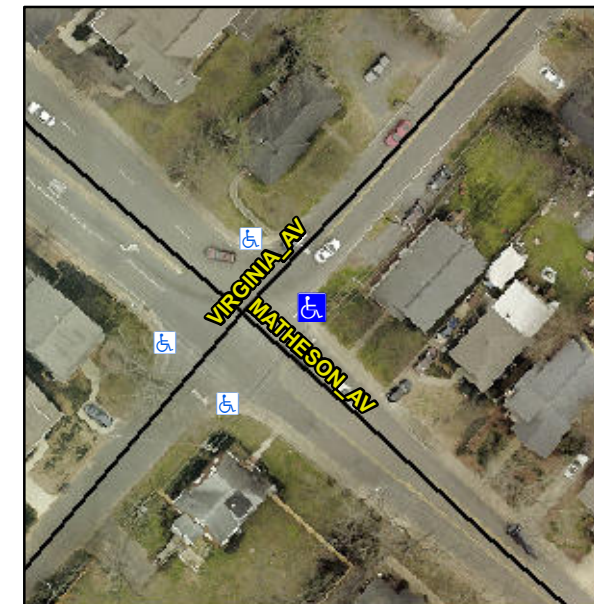
Not Found, R304.5.1

Compliance	Description	Data	Compliance	Description	Data
N/A	Ramp Length (in)	59.5	Yes	Ramp Slope (%)	5.4
No	Ramp Width (in)	39.5	Yes	Ramp XSlope (%)	1.0
N/A	Flare Type LT	N/A	N/A	Flare Type RT	N/A
N/A	Flare Slope LT (%)	N/A	N/A	Flare Slope RT (%)	N/A
N/A	Flare Traversable LT?	N/A	N/A	Flare Traversable RT?	N/A
N/A	Landing Length (in)	N/A	N/A	DWS Provided?	N/A
N/A	Landing Width (in)	N/A	N/A	DWS Contrast?	N/A
N/A	Landing Slope (%)	N/A	N/A	DWS Length (in)	N/A
N/A	Landing X Slope (%)	N/A	N/A	DWS Full Width?	N/A
N/A	Landing Curb? (Y/N)	N/A	N/A	DWS Offset (in)	N/A
N/A	Shared Landing?	N/A			
N/A	Gutter Ponding?	N/A	N/A	Gutter Slope (%)	N/A
N/A	Gutter Lip Ht (in)	N/A	N/A	Gutter X Slope (%)	N/A
N/A	Painted X Walk1?	No	N/A	Painted X Walk2?	No
	X Walk 1 Direction	To NW		X Walk 2 Direction	To SW
N/A	X Walk 1 Width (in)	N/A	N/A	X Walk 2 Width (in)	N/A
	X Walk 1 Slope (%)	4.5		X Walk 2 Slope (%)	1.9
	X Walk 1 X Slope (%)	1.3		X Walk 2 X Slope (%)	1.6

N/A	Ramp inside XWalk1?	N/A	N/A	Ramp inside XWalk2?	N/A
	Road Slope (%)	1.6	N/A	Clear Space?	N/A
	Road X Slope (%)	5.9	N/A	Clear Space to XWalk (in)	N/A
N/A	Any Obstructions?	N/A	N/A	Storm Grate/Utility Hazard?	N/A
	Obstruction Type			Storm Grate/Utility Type	
		N/A			N/A
			Yes	Surface Condition? (G/P)	Good

Remove & Replace Curb Ramp With Two New Directional Ramps or Equivalent.
